WACŁAW CELADYN\*

CLIMATIC ASPECTS OF DURABILITY  
IN CONTEMPORARY ARCHITECTUREKLIMATYCZNE ASPEKTY TRWAŁOŚCI  
W ARCHITEKTURZE WSPÓŁCZESNEJ

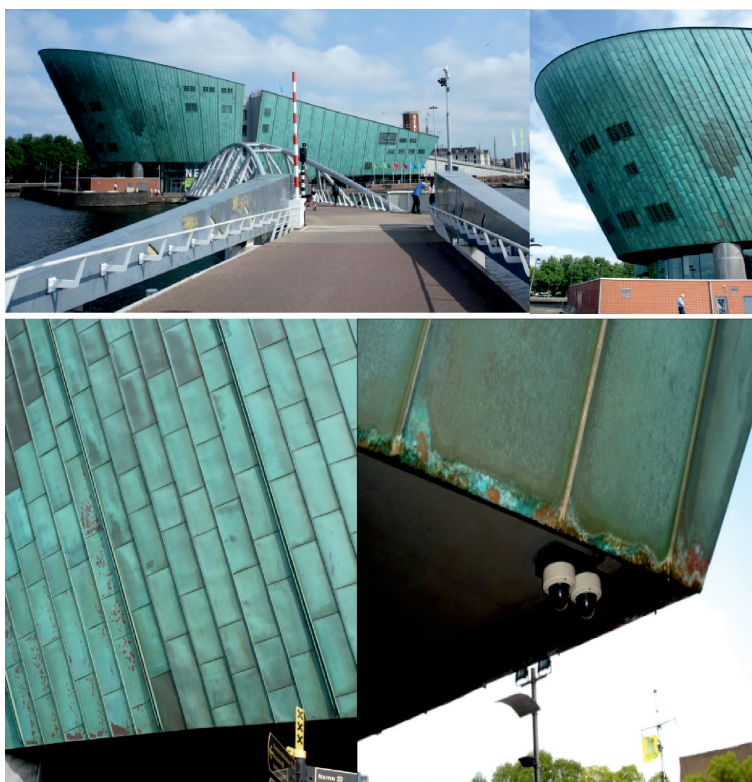
Ill. 1, 2, 3, 4. Nemo Science Center, Amsterdam (arch. R. Piano), 1997 (photo by author)

Among the analyzed examples of contemporary Dutch architecture, a spectacular case of deterioration, unexpected to this extent, is the building of the Nemo Science Center in Amsterdam. Located by the water, it is subjected to degradation of the technical and aesthetical values of its elevations (Ill. 1).

It was constructed in 1997, and after 17 years of its use presents visible symptoms of unintended damages to the copper cladding. This is the case of the north façade, which faces a nearby water basin. Traditionally resistant to climatic factors, the copper sheet has yielded to early degradation and a disfiguring process of patchy change of colour can be seen (Ill. 2,3). On the south elevation, a spotty tarnish on the patina and discoloured coating appears over a series of corrosion spots at the lower edge of the cladding (Ill. 4). Even during a nice, rainless weather, the water drips from it, due to a water basin and cascades located on top of the building.

It seems that the stains on the copper sheet and the apparent deposits of dust have appeared due to the detrimental action of climatic factors. It is the rain water, which has not yet washed off the dusty overlay from the negatively inclined façade during the multiple cycles of its watering. A proof of this process may be the lighter and natural colour of the copper elevation, that remained unchanged at its upper brim, as well as the apparent streaks made by the water flowing down the façade and dislocating the dust deposits, eventually forming darker patches below. Similar patterns can often be seen on the stone facades. More intensively washed vertical west elevation, which is subjected to the action of prevailing winds, is devoid of such disfiguring effects. This is probably due to its tilt encouraging the washing. (Il. 1). In the case of the south elevation (Ill. 3), the apparent spots of corrosion should be assigned to faulty workmanship, and possibly also to poor design solution. A shallow water pool with cascades, located on top of the building, has contributed to that deteriorating process. A faultless construction in this case would be a very difficult task. The one carried out on this roof has proved to be technically unreliable, causing the water penetration into the structure of the façade, and eventually its flow down the internal face of the copper cladding.

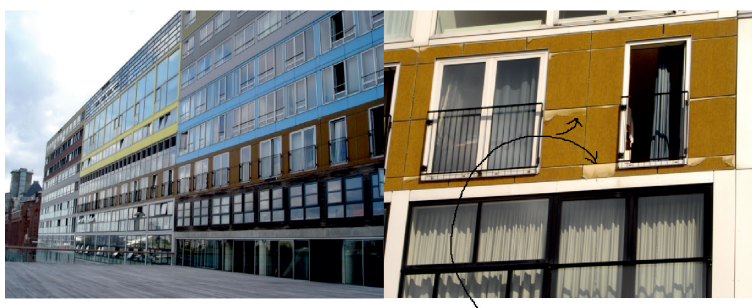
Ill. 5, 6. Office and residential building Silodam, Amsterdam (arch.MVRDV), 2002 (photo by author)

The building has been constructed in a climatically utterly adverse location, over the river bank, and founded on piles. It is a very windy place. The building facades are clad in a few various materials, being a designers' aesthetical option (il.5). After 12 years of its use, the majority of applied materials do not exhibit substantial apparent signs of deterioration, except for the fragments of the elevation clad in beige HPL (High Performance Laminate) panels. Some of them have been conspicuously damaged by the wind. Their outer finishing layer has partly come off along the edges (Ill. 6 ). This defacement of the outer skin of the building seems to have been unavoidable in such adverse climatic conditions. The synergetic action of the wind and humid air, as well as that of the slanting rains, have brought about the disintegration of this vulnerable cladding material. The bonding capacity of the resinous glue in those panels has presumably subsided, and ultimately has caused this negative effect. The HPL materials, having been in a relatively short-time use, have demonstrated their obvious flimsiness in such extreme conditions. That serious degradation could have probably been avoided, or at least reduced by the application of a waterproof framing along the edges of the panels. It would protect them from the penetration of rain water and humidity inside them.

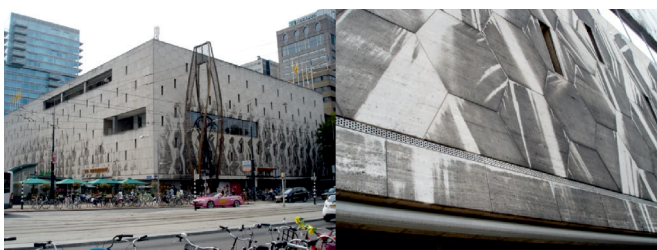
Ill. 7, 8. Shopping center De Bijenkorf, Rotterdam (arch. M. Breuer), 1957 (photo by author)

This building has its long history, and thereby, it is different from the new ones analyzed above. It was constructed in 1957 (arch.M.Breuer). The travertine-clad facades are marked with spectacular dark patches making a characteristic pattern (Ill. 7). Fifty seven years after their installation, they present quite a similar image as it was in the 18-th year of the building's use, when I perceived them previously. The high porosity of the applied stone favours the water penetration into its structure, resulting in an easy adherence of dust to its surface. A thick deposit of dust particles can be easily spotted on the building's east façade

exposed to a city's thoroughfare, where the dust is being intensively stirred and raised, due to heavy traffic. It is the lowest part of the façade, which is, quite understandingly, especially subjected to this process. The upper part of this elevation, being less intensively covered with dust, and more intensively washed with rain water, has maintained its original appearance. On the basis of an analysis of the superficial water flow, it can be claimed, that the intriguing patchy pattern on the facades has presumably been made as a result of their specific articulation. It was achieved by the use of identical hexagonal stone panels, separated by relatively deep joints, which had formed draining channels (Ill. 8). The changing direction of the local strong winds in this city have caused the streaks of rain water flow down the facades, in a way to form an irregular pattern of fragmentarily preserved dust deposits. As it seems, the porous character of the applied stone had made the procedures of cleaning and maintenance works, carried out at some time, visibly ineffective. They not only had failed to remove the dusty deposits, but presumably, even made them permanent. The analyzed effect of climatic deterioration of the facades, basically, does not reduce substantially the technical performance of the applied material, in this case. However, in the majority's opinion, it has a significant negative impact on the aesthetical values and durability of the building.

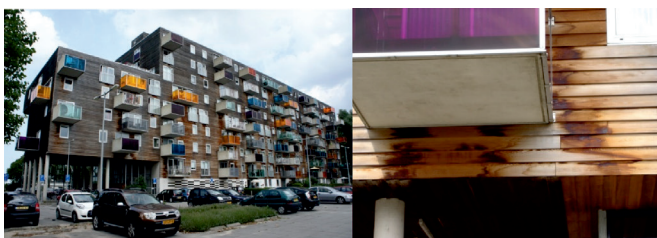
Ill. 9, 10. Seniors house WoZoCo, Amsterdam (arch. MVRDV), 1997 (photo by author)

It is particularly conspicuous on the south façade (Ill. 9), which is finished with horizontal wooden siding.

The brown planks have been sporadically marked with bleached streaks made by the rain water washing out the dark impregnant. This effect has, certainly, not been taken into account by the architects, as part of their initial aesthetical concept. Slanting rain water has made unevenly arranged patches of bleached material. The washed-out impregnant has been dislocated and spots of its concentration appeared in the direct vicinity of the streaks of water, which flowed down the façade forming darker irregular strips (Ill. 10).

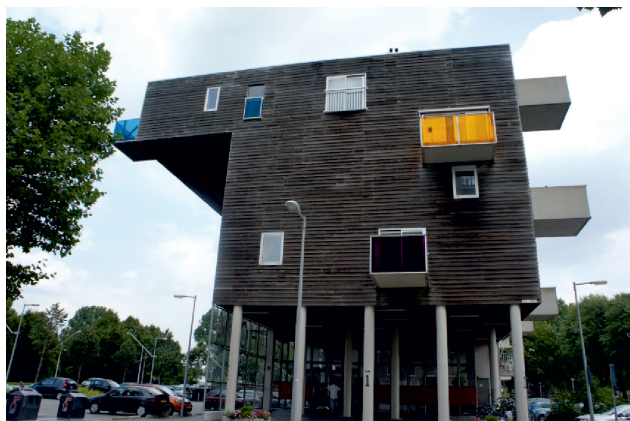
Ill. 11. Seniors house WoZoCo, Amsterdam (arch. MVRDV), 1997 (photo by author)

An analysis of the case indicates, that the irregularity of this pattern results from the unevenly located windows and balconies, which spectacularly protrude from the façade's plane. They protect some parts of the façade against the rainwater on the one hand, but on the other, they direct the streams of water to other parts of the cladding. Noteworthy is the comparison of the look of the south façade with the other ones. The west elevation has no discoloured patches (Ill. 11). This is due to its more advantageous orientation, in relation to the local dominating winds, as well as its protective screening by a neighbouring building and trees. This situation proves a diversified impact of climatic factors on building facades, depending on their spatial configuration.

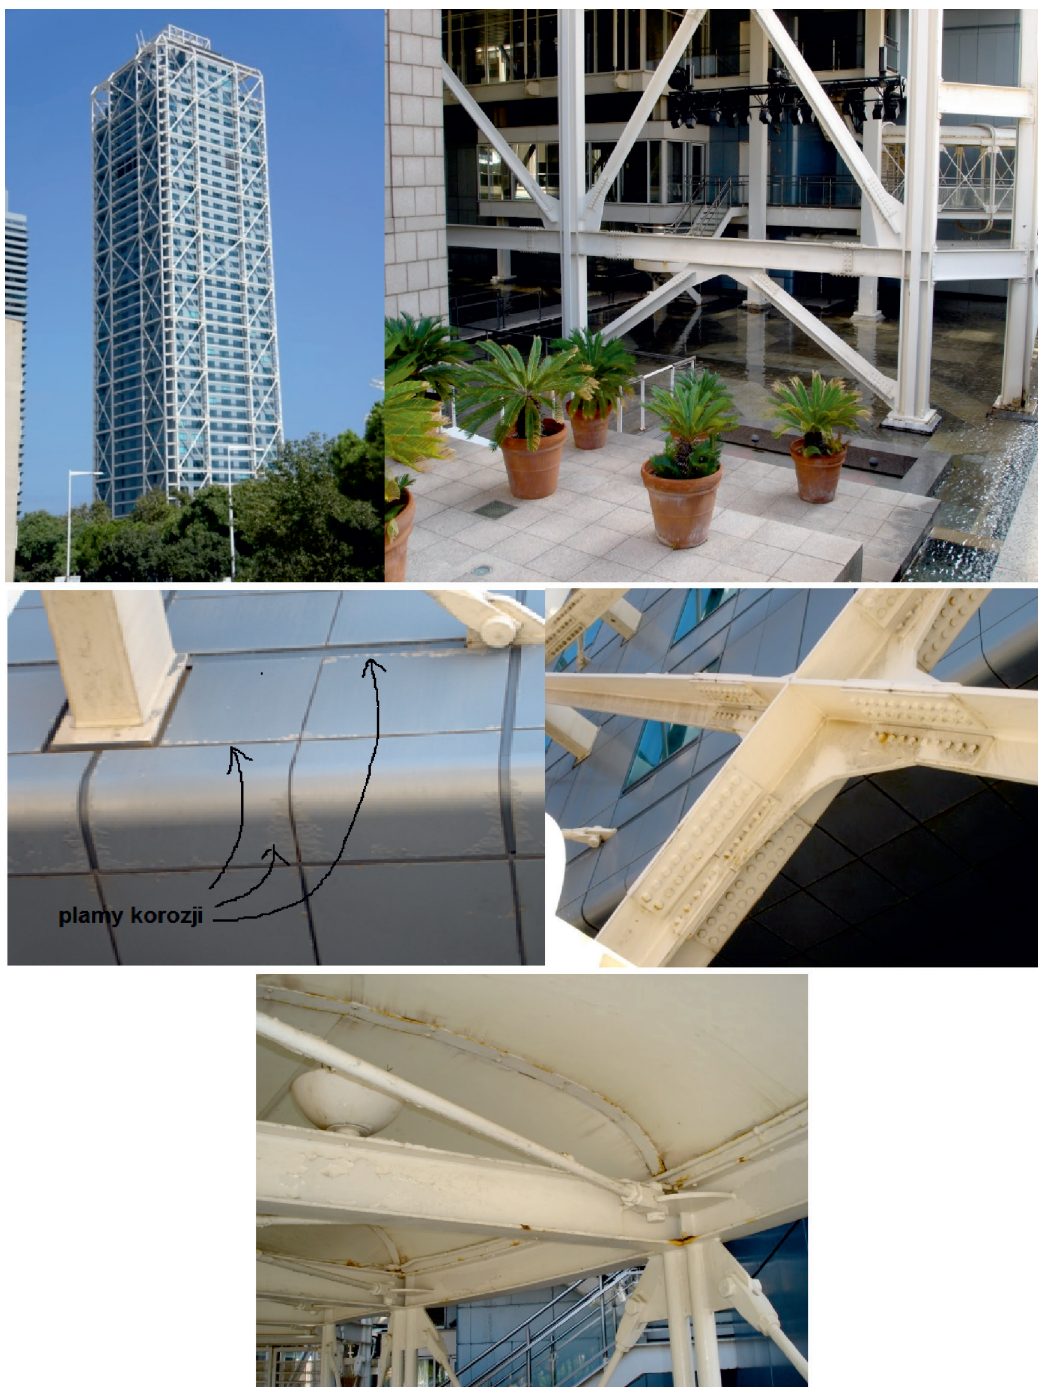
III. 12, 13, 14, 15, 16. Hotel Arts, Barcelona (arch. SOM), 1992 (photo by author)

This is a luxury high-rise hotel located directly at the coast of the Mediterranean Sea. It was constructed in 1992, and is a characteristic landmark of the coastal district of the city, due to its height and exposed external steel framing (II.12). The building is remarkable in view of the discussed problems of technical and aesthetical durability in architecture. Its structural concept, based on the use of steel, was rather risky, given the coastal location and salty air being ideal for the development of the corrosive process. After 22 years of its use, the building exhibits clear symptoms of the formation of corrosive spots, despite the protective anticorrosive treatment of its framing. This undesirable situation has been worsened by the installation of an open water pool under the building (III. 3). The rising water vapour acts not only on the structural elements, but also on the panels of metal cladding of the facades, which have deteriorated in part, and will need to be replaced at some later time (III. 14–16).

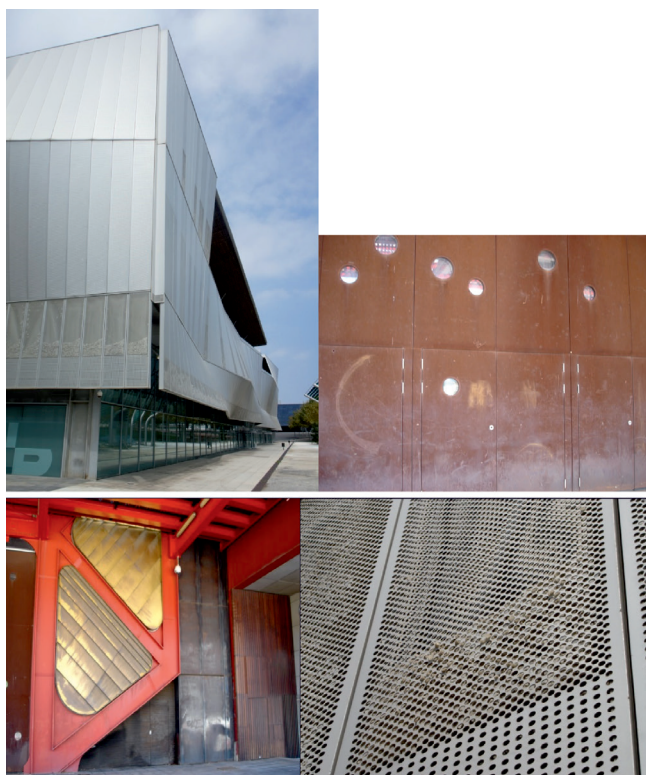
Ill. 17, 18, 19, 20. El Centro de Convenciones Internacional de Barcelona (arch. J.L.Mateo), 2004 (photo by author)

This is an ample conference building located in a coastal area of the city. After 10 years of operation, it shows exceptionally many symptoms of degradation that reduce its technical and aesthetical longevity (III. 17). Dominating are the damages and deformations of climatic origin that have contributed to the degradation of its facades. A process of dust accumulation had originated from a nearby heavy- traffic-artery and has found its expression on a lower part of the east elevation. It has been clad with brass sheet, which is protected against washing with rain water by protruding structural steel components above (III. 19). Another fragment of the elevation, located above, has preserved its original colour and technical value, due to the rain washing through a gap between the façade and contiguous canopy. A similar process was elucidated while considering the Dutch buildings. Quite an opposite, negative effect of climatic origin can be seen in yet another part of the building (III. 18), where a “corten” steel cladding has been devoid of an impregnative and corrosive layer in its lower part, because of the missing protection against slanting rain by the protruding elements of the façade. The resulting light patches on the metal sheet have disfigured the vulnerable material. The aesthetically and technically negative effect was further worsened by some ensuing perceivable maintenance procedures aimed at the removal of graffiti that had covered the metal. It has become obvious over time that the choice of this material had not been adequate, due to its vulnerability to vandalistic acts of mechanical character in that socially specific area. Glazed openings, in that same fragment of the elevation, have been responsible for unaesthetical markings made by the rain water or condensed vapour flowing in streaks down the panel. If, in the case of the two previously analyzed components, some maintenance procedures can presumably lead to the regaining a close-to-original result, the latter exposed to adverse climatic effects can only be completely replaced.

Another disadvantageous disfiguring process, taking place on the elevations over the ground floor, can be easily noticed. The majority of steel panels of the facades have been irreparably deformed and damaged (III. 20). That time, however, it was another adverse climatic factor and its destructive impact that had caused it, namely solar radiation. Intensive insolation, characteristic of that coastal geographic latitude, has brought about thermal movements of panels made of perforated stainless steel. Deformation, and ensuing delamination of those panels, as well as further slipping down of the soft polyurethan foam interleaf comprised between two thin metallic covers making a component, have become a spectacular example of technical and aesthetical failure. This effect had been caused by cyclic extension and contraction of the material exposed to such extreme thermal load. These movements have led to the destruction of bonding material holding all the three layers in place and, in consequence, to sinking of the foamy interlayer. The bulging of metal sheets had generated the delamination process and the creation of air

gaps between them. A decisive factor at the origin of this series of events was a fixed joining of layers at the perimeter of the panels. That hampered their mutual free thermal movements. Noteworthy is that the bulging and delamination were most intensive at those areas of the panels where the perforation was dense, and thereby the metal sheet more prone to deformation (il. 20). Permanently disfigured steel sheets are, in practice, a material unsuitable for correction. The analyzed process had been difficult to foresee as the applied stainless steel sheet has a lower value of the coefficient of thermal expansion than a regular steel. Therefore, it could have been assumed that it would not succumb to such deformations so easily. And yet it has happened.

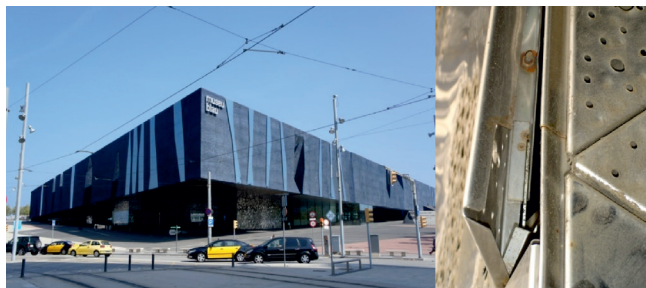
Ill. 21, 22. Museum of Natural History Museu Blau (arch. Herzog&de Meuron), 2012 (photo by author)

The Museum of Natural History, designed by Herzog&de Meuron, was erected in 2012. After only 2 years of its use, it shows signs of technical and aesthetical degradation attributed to climatic factors, but also to mechanical disfigurement caused by vandalistic acts to which the building has proved to be vulnerable (Ill. 21). In this case, presumably, a destructive impact of climate, coupled with the salty air, have become a real problem. Although the ground floor area is well protected against the rain water by the overhung upper story, there are many corrosive spots on the stainless steel panels of cladding and its steel fixing elements on this level (Ill. 22). The corrosive process favoured also an increased accumulation of dust on metallic elements, which is reaching the site from a nearby busy street.

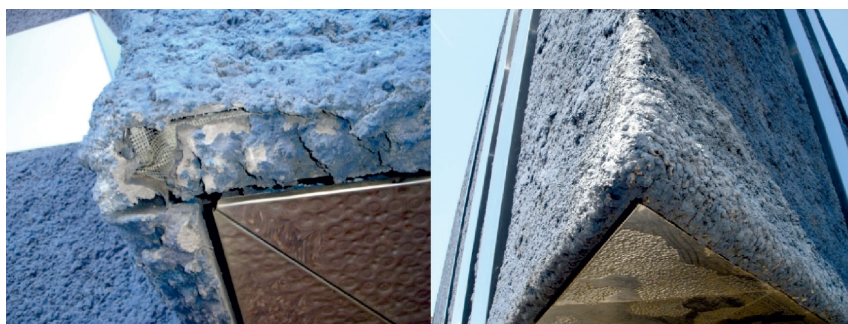
Ill. 23, 24. Museum of Natural History Museu Blau (arch. Herzog&de Meuron), 2012  
(photo by author)

The building exhibits the results of some other detrimental processes caused by the factors different from climatic. The lower parts of the upper story facades turned out to be vulnerable to damages done by the passers-by out of pure curiosity. That was possible due to their accessibility from the ground level. The plaster finish was systematically chipped off at its edges. These disfigured fragments are the price of the application of an innovative plastering technology, which attracts attention, and thus provokes an undesirable behavior of visitors (Ill. 23). The plaster finish painted in violet, due to its rough surface, is prone to excessive accumulation of traffic dust as well as of the beach sand blown onto it by the wind. As a result of that, the protrusive spots of the plaster finish brought about yellow patches of accumulated dust and sand on the elevation. The sculptural character of the external finishing material is also associated with another disadvantageous process, which consists in systematic, uneven washing of the façade by the rain water and disappearing of the violet paint. Disfiguring brighter patches gradually appeared making the façade's look even worse. This process will certainly, constantly proceed, and will lead to the aesthetical degradation of the building (Ill. 24).

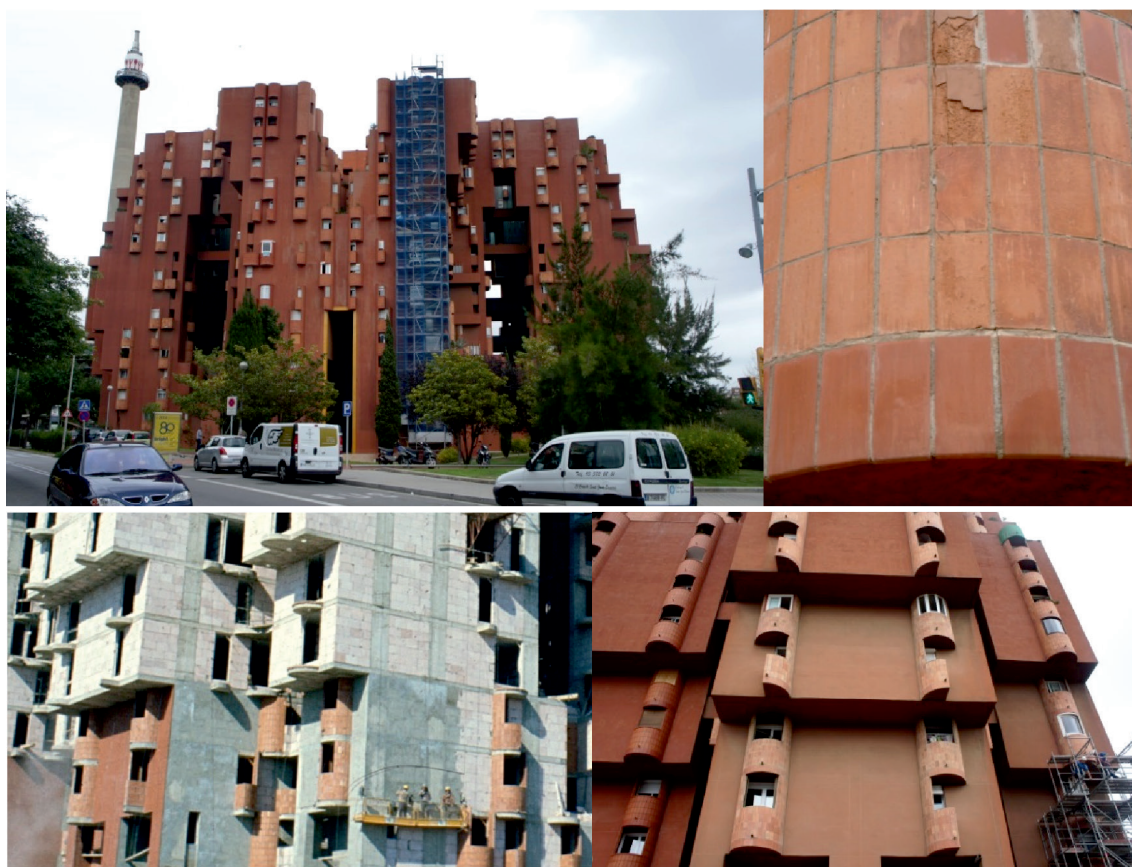
Ill. 25, 26, 27, 28. Residential building Walden 7 (arch. R. Bofill), 1975 (photo by author)

The building is interesting for its history, and it very well illustrates the problems of durability of buildings (Ill. 25). It was completed in 1975. Its structure is made in a concrete framing technology with exterior walls of light concrete blocks (Ill. 27). Directly on this material, a ceramic tile finish of low quality on all the facades has been installed (Ill. 26). The architect was apparently not aware of the future problems with that technical solution, but they appeared not much later. In 1988, after 13 years of its use, on my second visit to the site, the building was surrounded with a mesh canopy, which was designed to protect the passers-by against the ceramic tiles coming off the facade and falling down. The reason of that endangering process were the changes in the air temperature and the resulting cyclic thermal movements of tiles, which would break the bonds between them and the fixing mortar. Moreover, the condensation of water vapor from inside the building, which would penetrate the walls of high vapor permeability, had contributed to

such a result. The high temperature of dark red tiles, heated by the solar radiation, brought about presumably the increased pressure of water vapour within the structure of the wall and, in consequence, made the tiles come off. As a climatic factor, the solar radiation had certainly become the main destructive reason of the failure of the façade's material. It is noteworthy, that the diffusion of water vapour through the exterior walls, and its negative consequence: the reduction of the technical durability of buildings, have not been seriously considered, so far, in the Mediterranean countries with clement climates. It has not been a real problem in that region, due to the dominating one-material technology for exterior walls. But it appeared to be a problem in the analyzed case of the residential building, characteristic of the increased humidity of the interior air. The external finish of ceramic tiles, impermeable for water vapour, had been installed on light concrete blocks characterized by a high rate of vapour permeability. From our view point, it is an obvious faulty solution, contrary to the accepted rules in building design. As a result of unexpected damage to the elevations, refurbishment works have started. The tile finish is now being replaced with coloured plaster on the whole façade, except for the balconies and bay windows, where the old tiles are being replaced with new ones of higher quality (Ill. 28). This building is stricken not only with the aforementioned problems, but also with another type of deterioration. The owners of some apartments have remodeled their balconies and replaced the original windows with new ones of different sort, in an uncontrolled way, thus an esthetical "destruction" has taken place (Ill. 28).
