ŁUKASZ ZDANOWICZ*, RYSZARD WOJDAK**

STRUCTURAL ANALYSIS OF A FAILED RC BEAM WITH OPENINGS IN A BUILDING UNDER CONSTRUCTION

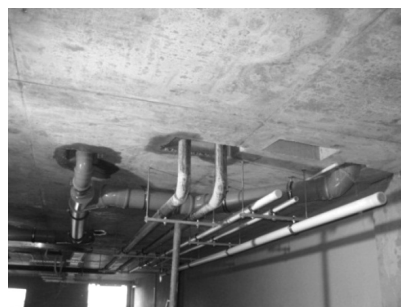
A lot of holes for installations were made in the load-bearing elements during the construction of the building. They were made in slab floors, beams and walls (see Fig. 2a–Fig. 2g). The majority of these holes were made defectively, causing unexpected structural response.

Fig. 2a. Openings in load-bearing elements

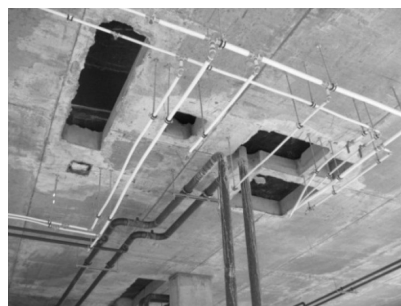
Fig. 2b. "Random" openings in a floor slab

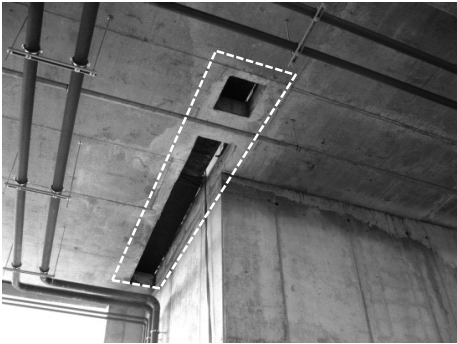
Fig. 2c. Openings designed in floor slab (marked by dashed line)

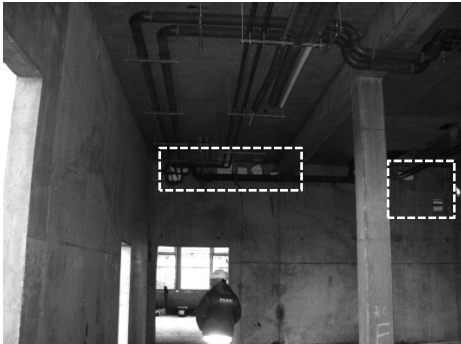
Fig. 2d. Uncontrolled openings in a load-bearing wall

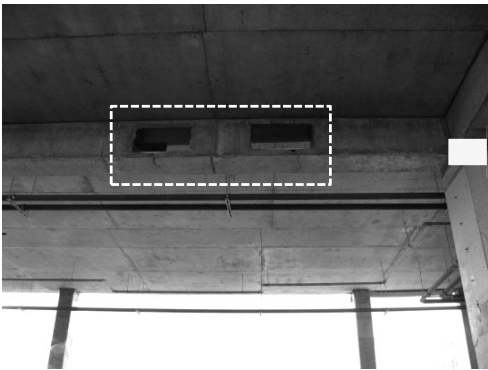
Fig. 2e. Defectively designed openings in beam (cracked lower strip)

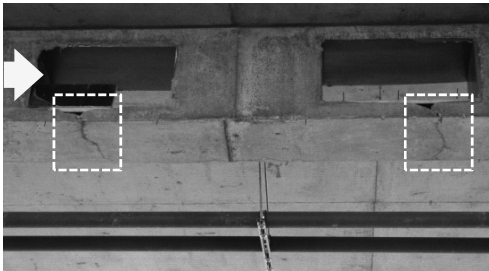
Fig. 2f. Detail of Fig. 2e

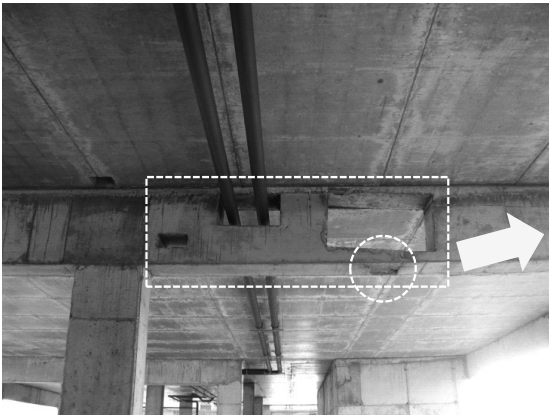
Fig. 2g. Failed beam

Fig. 2h. Detail of Fig. 2g (concrete decrement in lower strip)

An analysis was performed of selected, critical area of the structure (beam with openings and a floor slab in section J/VII-VIII – Fig. 2g and 4; element number BW-I-3.2, construction drawing no. IP026_PW_DR_2542_RC). Two models were developed:

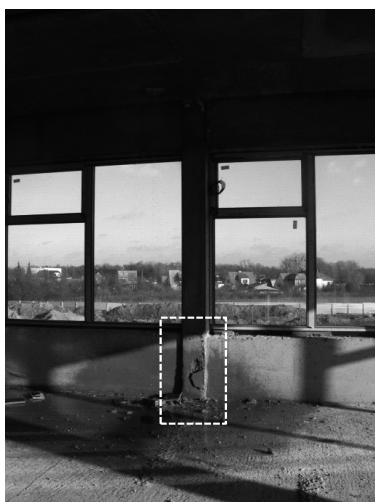
Fig. 3a. Damaged column

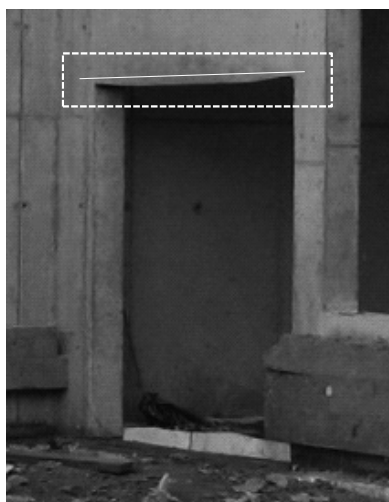
Fig. 3b. Deflection of doorhead due to wrong shoring procedure

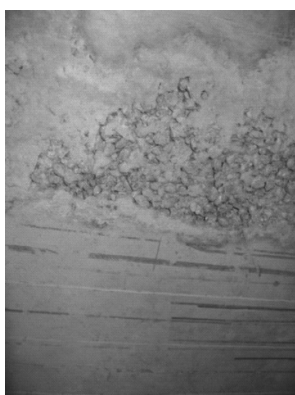
Fig. 3c. Defective concrete placement

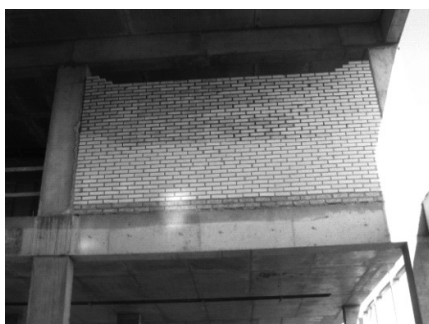
Fig. 3d. Internal wall made of solid bricks (is it needed?)

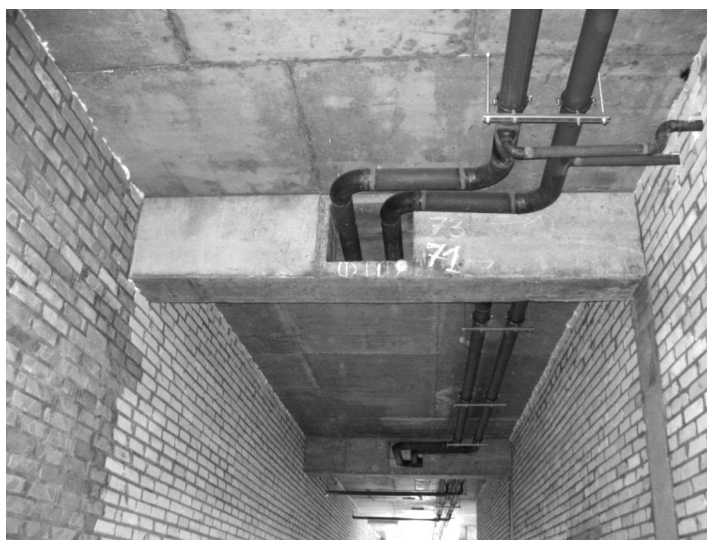
The intention for the presented observations was to voice an opinion about a still timely problem of communication between Designer and Contractor in building projects, and in particular related to supervision, coordination and quality of these works. Despite more and more advanced tools used in engineering, up to now, nothing can replace the human factor (which usually is an adequate experience) [6]. Providing required level of structural reliability does not depend on the use of modern tools – it depends not less on good habits, experience and integrity during everybody’s own work. Let the figure below (Fig. 12) be the punchline, which quite clearly illustrates the problem of quality and coordination in the building process.

Fig. 12. „Well-founded” construction of the opening in beams
