TECHNICAL TRANSACTIONS

5-A/2014

PRESERVATION AND RESTORATION OF GREENERY IN HISTORICAL CEMETERIES IN SLOVAKIA

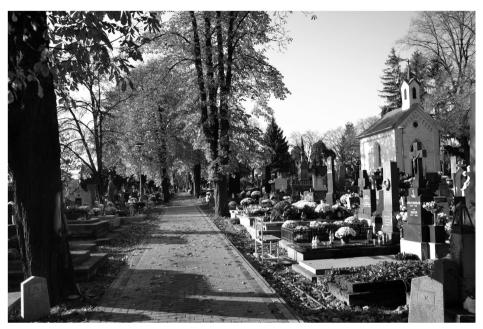
III. 1. Current state of the Aescuculus hippocastanum L. avenue in the Main Municipal Cemetery in Nitra (photo by D. Halajová, 2012)
