**TECHNICAL
TRANSACTIONS**

**CIVIL
ENGINEERING**

**ISSUE
3-B (23)**

**YEAR
2015 (112)**

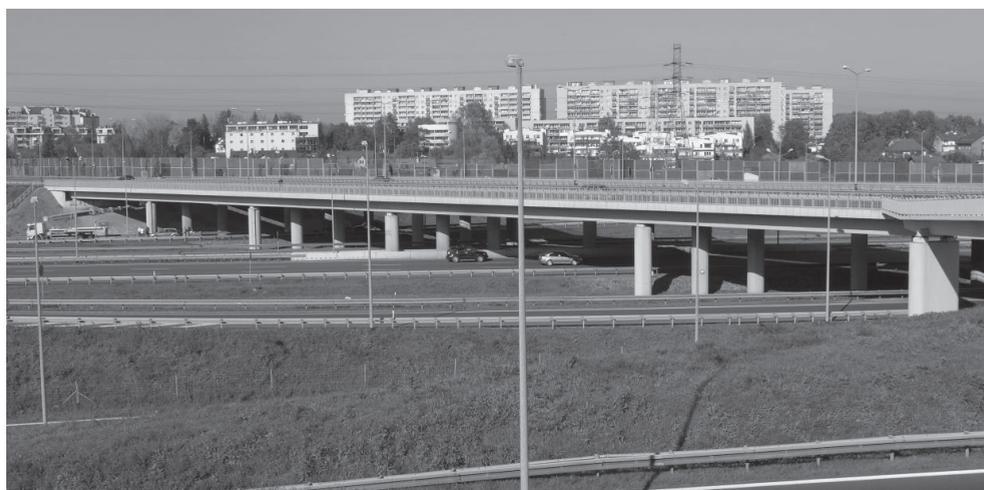
The present paper is related to a bridge structure located at a G2 class main road axis over a motorway in the south of Poland (Fig. 1). The bridge built over the motorway is composed of two parallel, load-bearing structures. The cross-section of each of them is composed of three girders and there are six spans along the length of the bridge. The angles of intersection with supports and abutments axes are variable. The bridge is built in an area of geologically non-stable ground – this fact was already known at the time of construction. In effect of the ground settlements, redistribution of internal forces in the load-bearing structure was possible and this effect could provoke the structure overloading.

Fig. 1. View of the structure

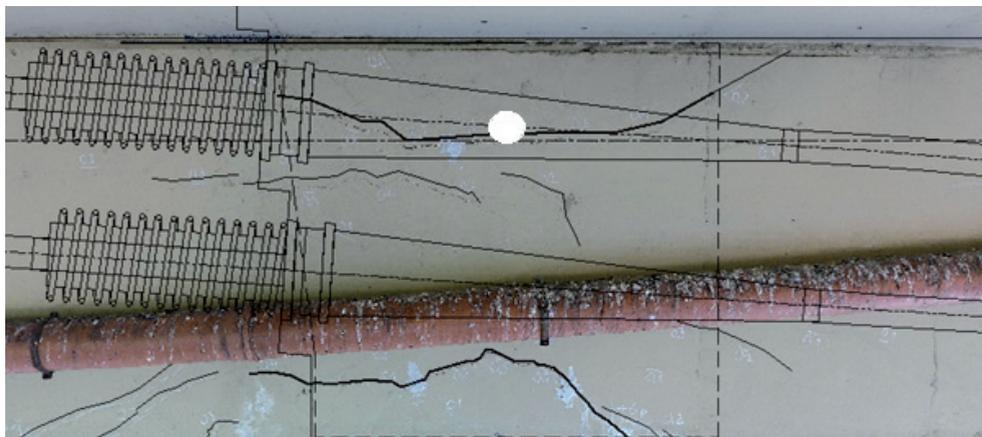
with a high concentration of cracks is located directly at the construction joint, which is 5.0 m from the support. Fig. 2 presents the crack distribution over the surface of the beam together with the position of the cable ducts and the joint between the construction segments built successively.

Fig. 2. Layout of cracks on the beam surface and the position of the joint between the structure segments and prestressing cable ducts

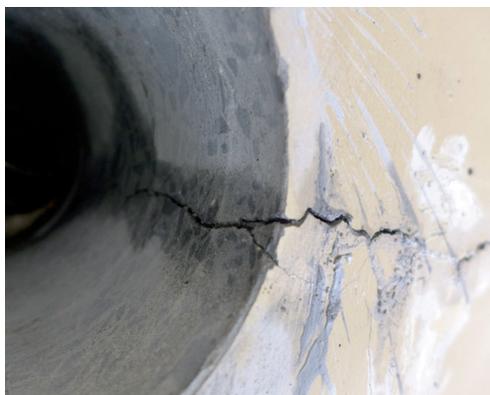
Due to the large width of cracks observed on the member's surface, the decision was taken to drill a core specimen along one of the cracks. The aim of this drill specimen was to investigate the depth and direction of the crack. The drilling was positioned at the level of the axis of the upper prestressing tendon, where the diameter of the cable duct progressively changes from 275 mm at the coupler to 100 mm at the entrance to the regular cable duct. In Fig. 2, the position of the drill is shown (indicated with a white dot). Because the crack width (Fig. 3) observed in the direction perpendicular to the surface was not decreasing, the drilling continued until the steel cover of the cable duct was reached. Inspection of the drill surface revealed the presence of another crack perpendicular to the drill axis and located 80 mm below the concrete surface. This crack is visible in the upper part of the drilled wall, slightly before the steel shield of the cable duct (Fig. 4). The observation of the crack inside of the drill specimen is in line with another observation of the concrete cover spalling – this was confirmed by means of an acoustic check of the concrete surface using a metal hammer.

Fig. 3. Crack position in the drill wall of the beam under investigation

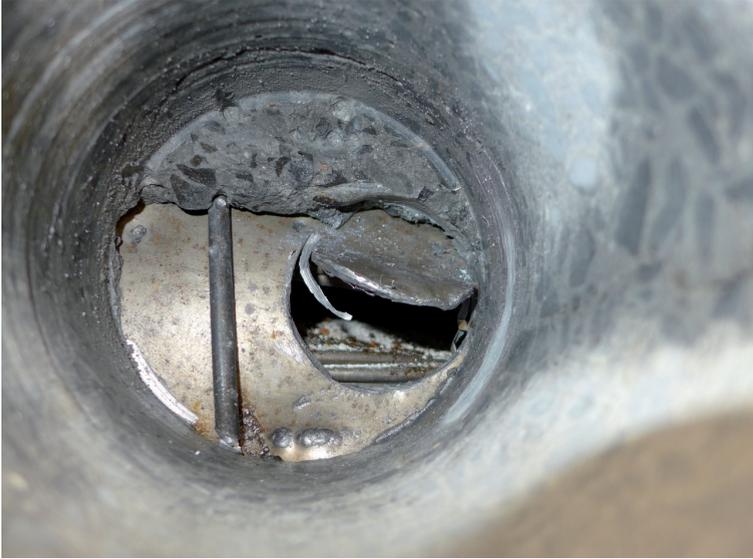
Fig. 4. View into the drilled hole in the girder subjected to investigation. The steel cover of the prestressing cable duct and its interior are visible

Observations regarding materials inside of the structure in the area of drilled cores also brought many interesting observations. After penetrating the cable duct shield, it was found that instead of the duct being completely filled with cement grout as expected, there was a substantial lack of grout (Fig. 4). Punctual corrosion of the stressed, exposed prestressing strands was also found inside of the duct. The mortar filling the bottom part of the prestressing cable duct was non-cohesive – it was in the form of a powder with a grain size of 1–4 mm and with a white-beige colour. The lack of grout in the proper form, local corrosion of the prestressing strands as well as the corrosion points on the surface of the cable duct shield are evidence of the risk of tendon corrosion. The interior of the cable duct is shown in Fig. 6. Naked strands, local corrosion of the prestressing steel as well as of the internal surface of the duct shield was observed. Moreover, concrete splitting from the external surface of the cable duct shield was also observed (Fig. 4).

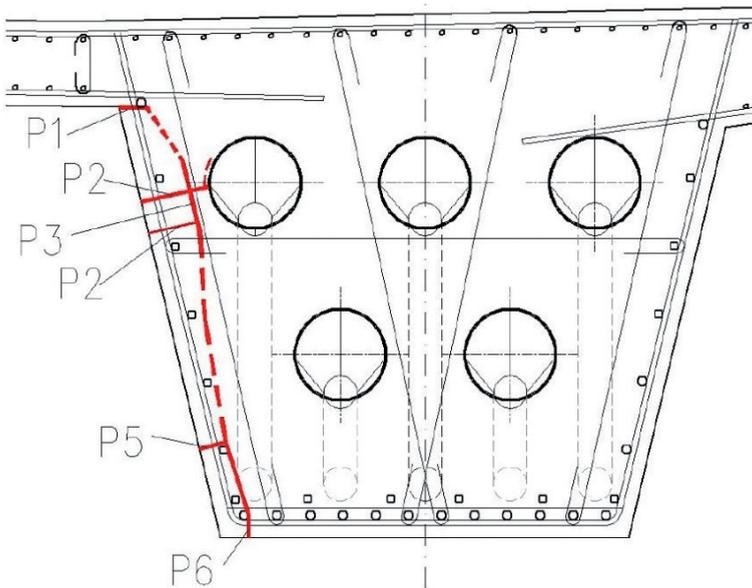
Fig. 5. Spalling of concrete along the depth of the girder – the continuous line represents the observed cracks, the dashed line represents their hypothetical trajectory. P1 to P6 – observed locations of cracks

The acoustic check indicated that the spalled layer occurs on the whole vertical edge of the beam from the slab at its top to the bottom edge and the length of the damaged area along the beam exceeds 2.5 m. The position of the observed splitting and its hypothetical trajectory are shown in Fig. 5.

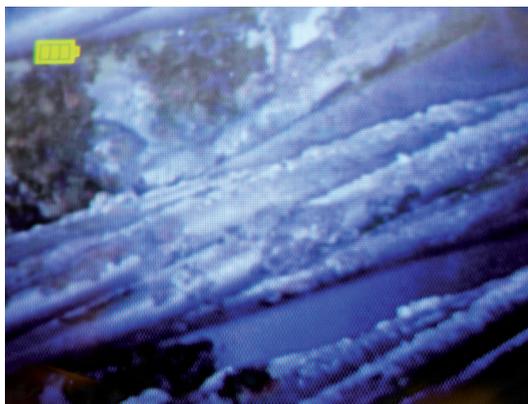
Fig. 6. View of the interior of the prestressing cable duct

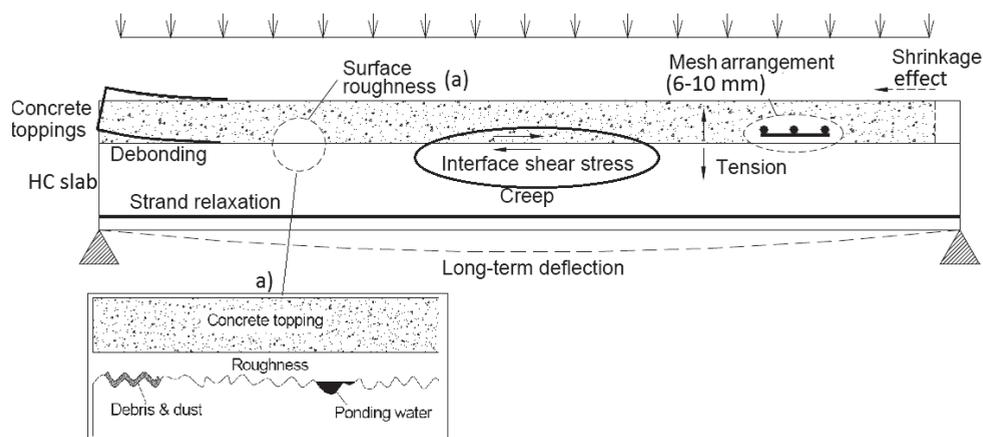
The analysis of the bearing capacity of the interface between the concrete topping and the precast element under longitudinal shear in the aspect of design guidelines and international experimental research is considered in this paper. In actuality, this is a very complex problem, since on the behaviour of this interface influence not only the magnitude and type of both direct actions (for example operational load) and indirect actions (for example shrinkage and creep of concrete), but also number of the factors connected with the execution of the structure (for example the material characteristics of concrete, shaping of the joint interface, its moistening, contamination, possible cracking, presence of laitance etc.) Factors having an effect on the quality of HC slabs with topping composite action are graphically presented in Fig. 1 [6].

Fig. 1. Factors influencing the composite action of the HC slab with topping [6]

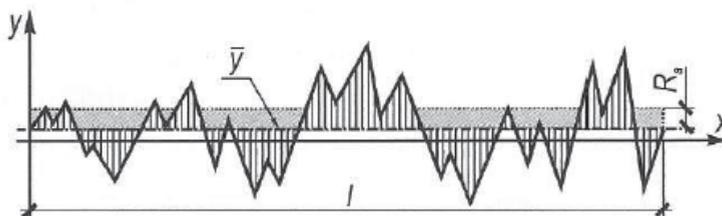
The basic parameter which characterises the surface of the precast element is the average roughness R_a – this represents the medium deviation of the surface profile from the medium line (Fig. 2).

Fig. 2. Definition of the average roughness

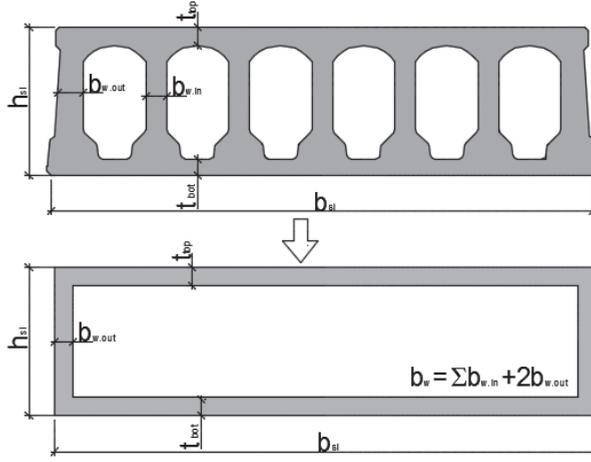
Other geometrical denotations for the purpose of the W_T calculation are given in Fig. 4.

Fig. 4. The method of transformation of the real HC slab cross-section into a reduced thin-walled cross-section

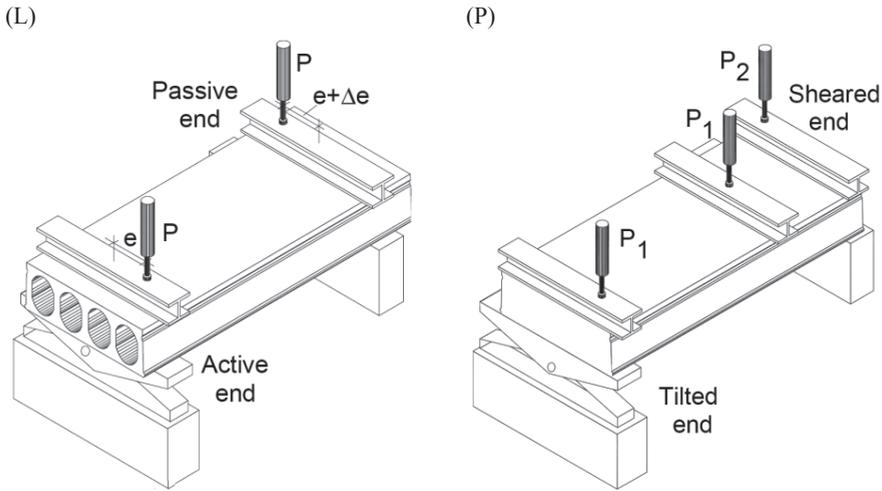
Fig. 5. Testing stand for pure torsion (L) and torsion-shear interaction (P) [11, 12]

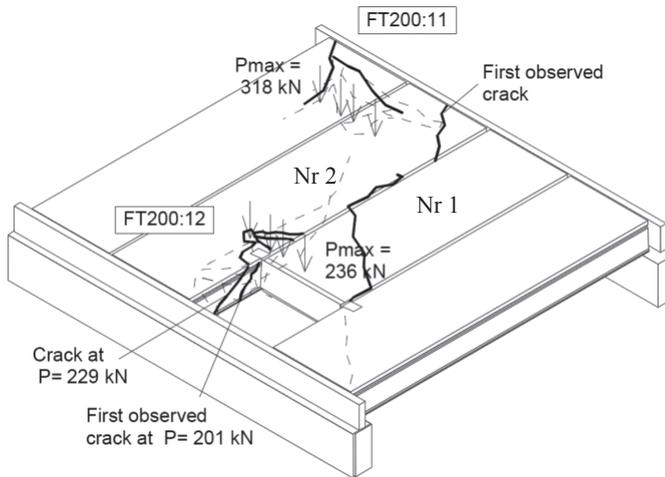
Fig. 6. Testing stand for the torsion-shear interaction for HC200 with the recess [13]

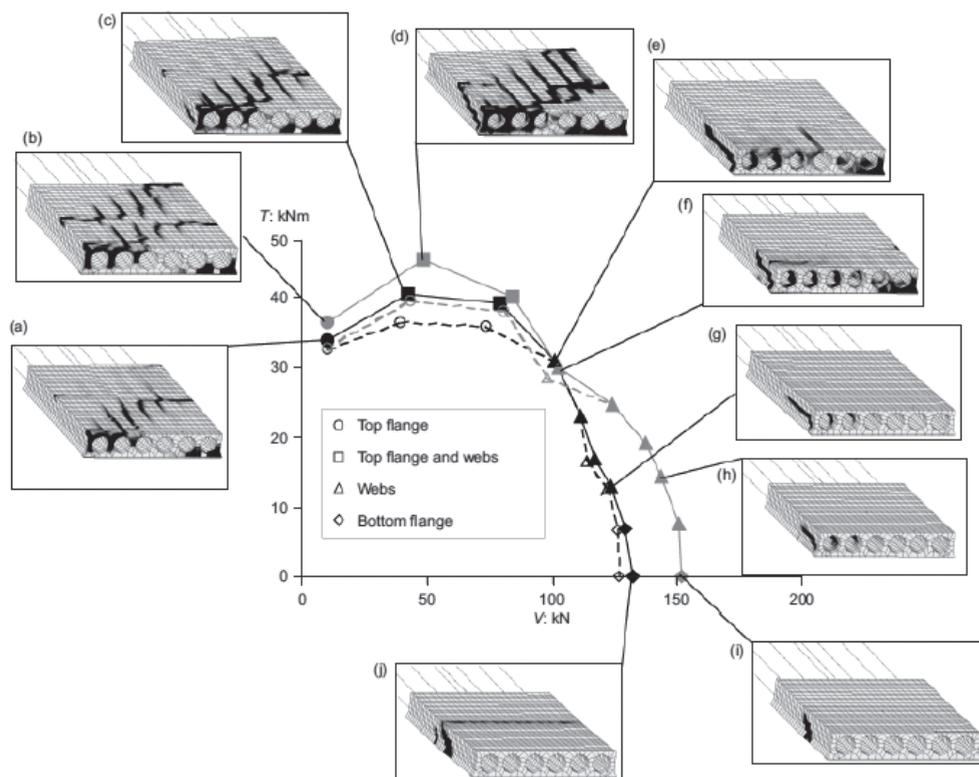
Fig. 7. Torsion and shear interaction for HC200 slab, according to the Holcotors numerical model

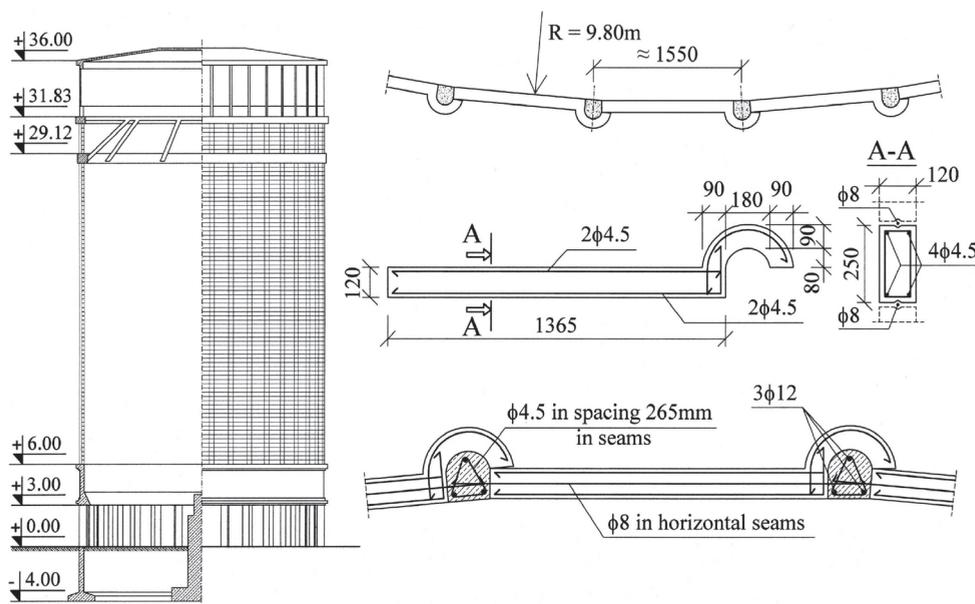
The structure of the tower is mixed (Fig. 2). The foundation up to a level of +6.00 m is formed by a reinforced concrete monolithic structure with a height of 3.0 m supported by columns. The main part of the cylindrical shell between the levels of +6.00 and +32.00 m

Fig. 2. Geometry and structural details of the granulation towers

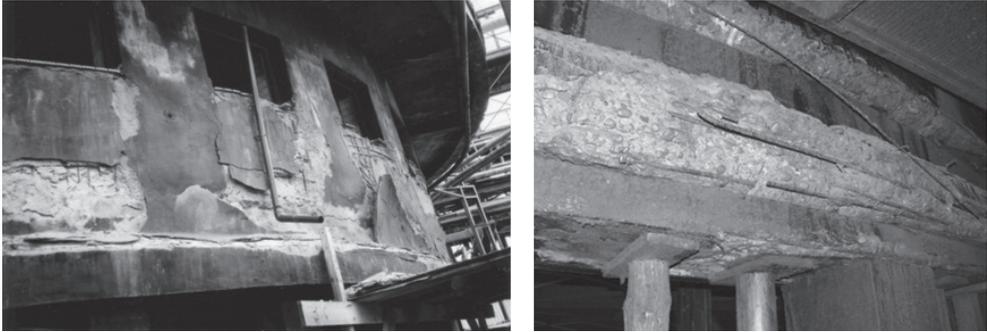
Fig. 3. Corrosion of monolithic foundation of the tower in 2002

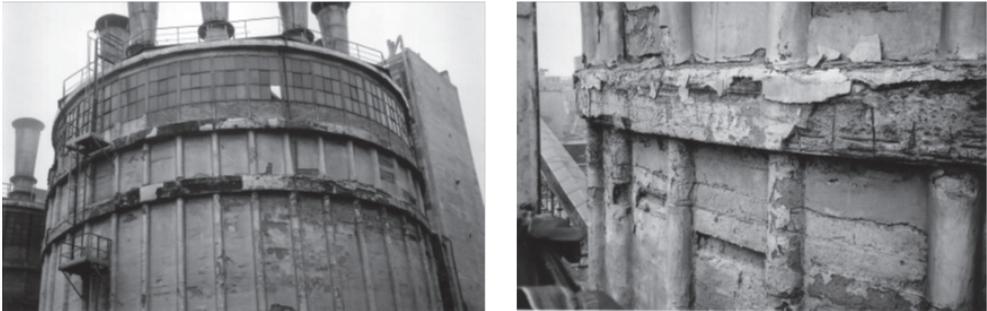
cylindrical shell (Fig. 4) were seriously destroyed. Losses of concrete in the prefabricated wall reached two-thirds of the wall thickness. Additionally, there was considerable local damage to the cross-section of the vertical ribs. In the lower monolithic part of the tower, the concrete cover of the cylindrical walls, columns and tie beams were damaged. Almost completely corroded reinforcing bars were localized.

Fig. 4. Corrosion of the prefabricated cylindrical shell (2002)

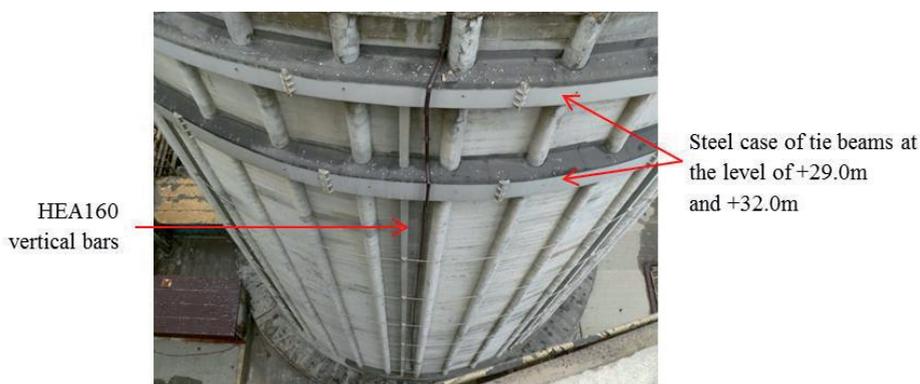
The reinforcement of the tie beams at a level of +29.12 and +31.83 m were designed in the form of steel casing as well as additional 10 HEA 160 vertical bars extending from a level of +6.0 to +29.12 m and anchored to the prefabricated cylindrical wall (Fig. 5). The role of the designed reinforcement was to safely transfer the loads from the top of the tower (technological ceiling, flat roof and reinforced concrete upward extension) and relieve the prefabricated coating.

Fig. 5. Steel reinforcement of the granulation tower

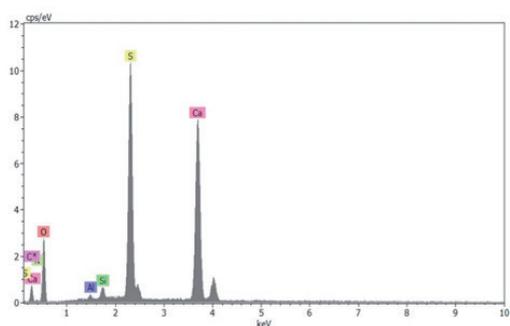
Fig. 7. The results of the observation of the concrete sample in the scanning electron microscope: a) leaky structure formed by the processes of dissolution and sulfate corrosion; b) EDS analysis results (ettringite formation)

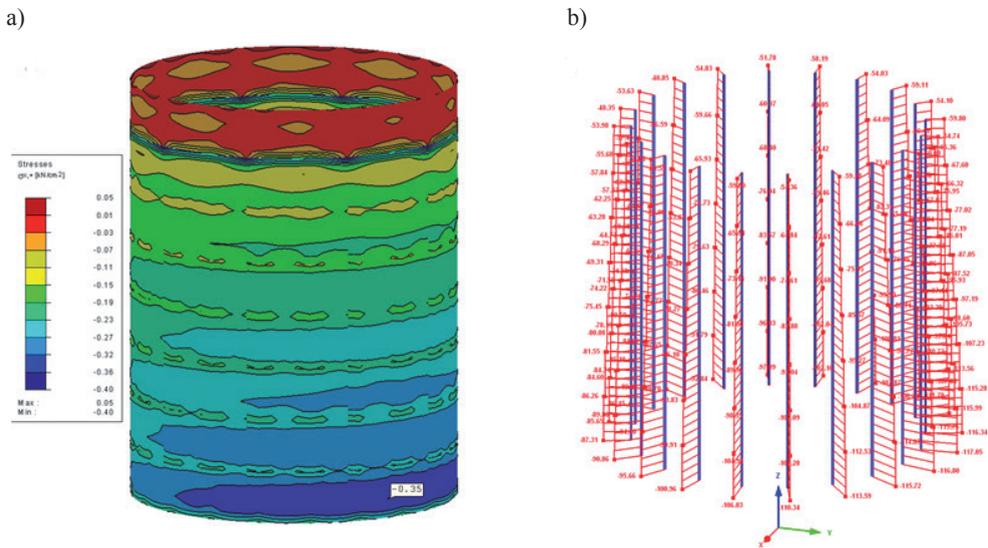
In Figure 8, the analysis of the results in the form of vertical stresses in the coating (8a) and forces in the steel pillars (8b) for Option 1 are presented. Compression in the concrete

Fig. 8. The results of static analysis of the structure for Option 1: a) concrete shell vertical compression [kg/cm²]; b) steel pillar forces [kN]

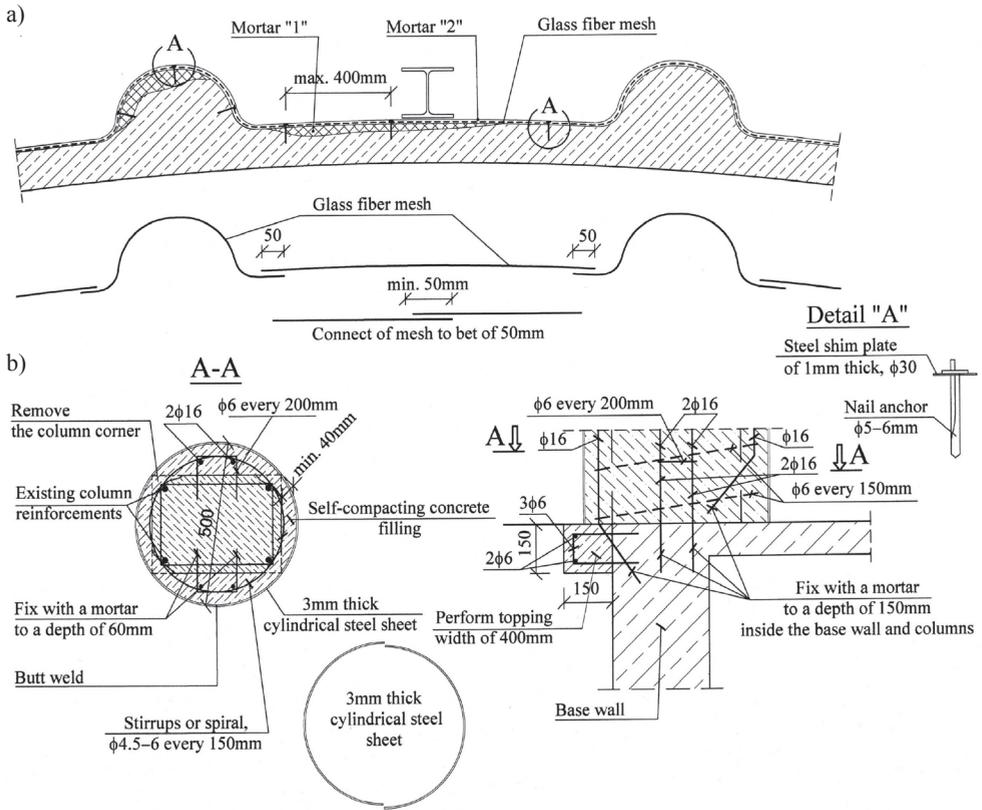
Reinforced concrete foundation columns were encased in a 3mm thick steel layer (Fig. 9b) after all loose and cracked concrete parts were forged together. After prior reinforcement of concrete filling of a steel casing in accordance with Fig. 9b (4mm vertical bars ϕ 16, pasted into the parent concrete, transverse stirrups and pasted bonding inserts), the inside of the casing was flooded with self-compacting concrete.

Fig. 9. a) details of protection of prefabricated concrete shell; b) reinforcement of foundation columns

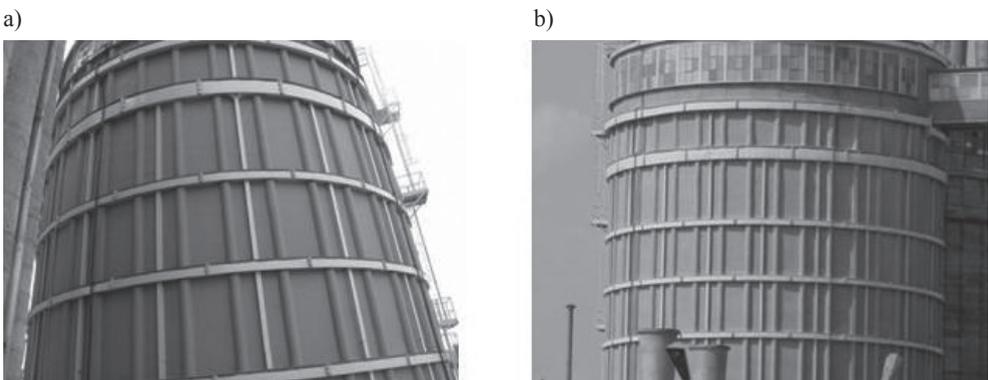
Fig. 10. a) the granulation tower shortly after renovation (mid-2012); b) the same tower after 2.5 years of operation

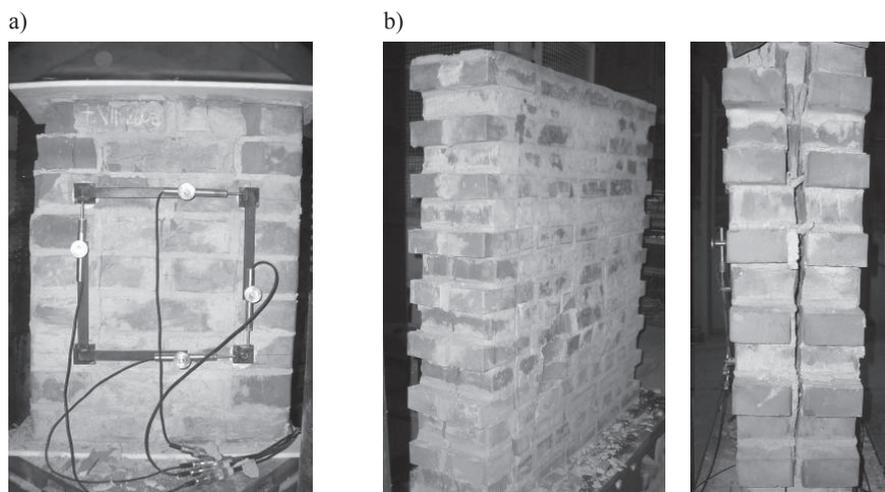
Fig. 3. Failure of: a) CV type model; b) MW type model

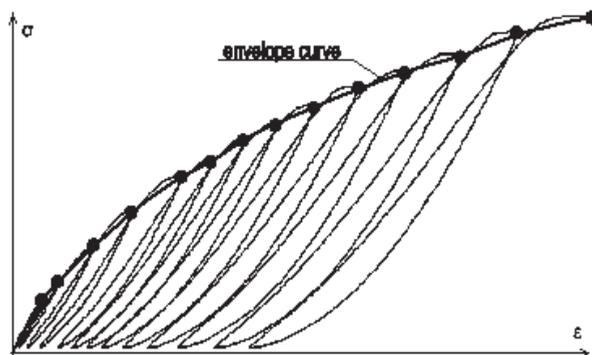
Fig. 4. Typical σ - ε relationship for masonry subjected to cyclic loading with the construction of the envelope curve

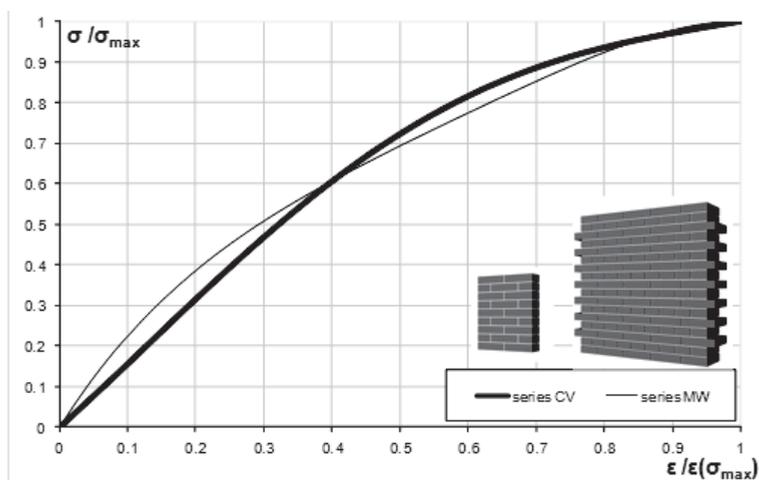
Fig. 5. Averaged normalised envelopes for MW and CV series models

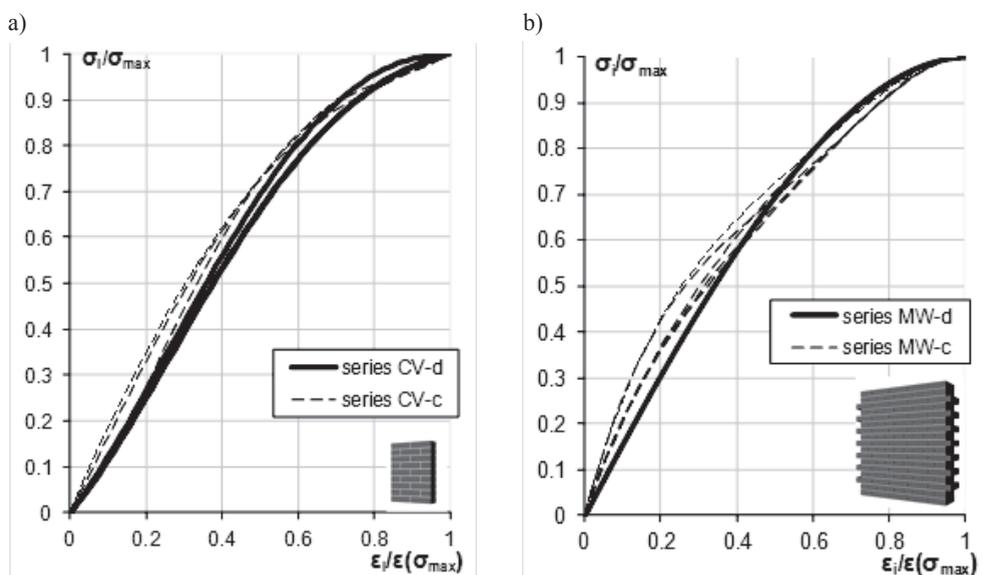
The next diagram (Fig. 6) presents $\sigma/\sigma_{\max,i} - \varepsilon/\varepsilon(\sigma_{\max,i})$ relationship for the one cycle tests (continuous line) and the failure envelope obtained from the cyclic tests (dashed line) for the CV and MW masonry walls series.

Fig. 6. Normalised $\sigma/\sigma_{\max,i} - \varepsilon/\varepsilon(\sigma_{\max,i})$ relationships for: a) CV, b) MW series models

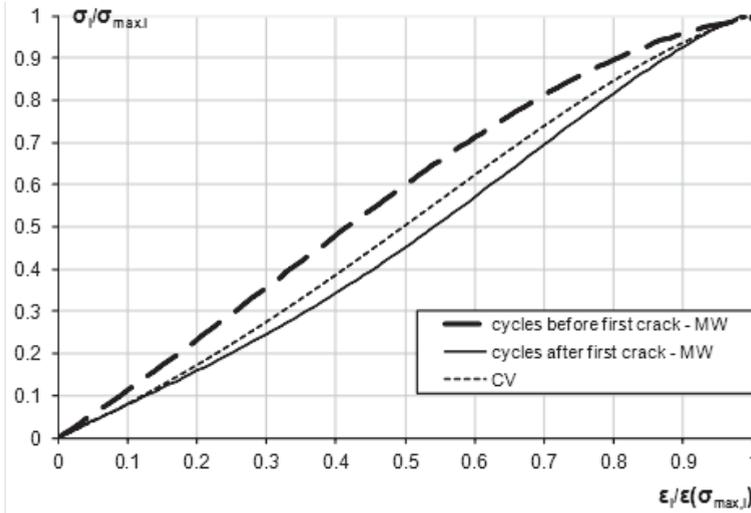
Fig. 8. Normalised loading curve $\sigma_i/\sigma_{\max,i} - \varepsilon_i/\varepsilon(\sigma_{\max,i})$

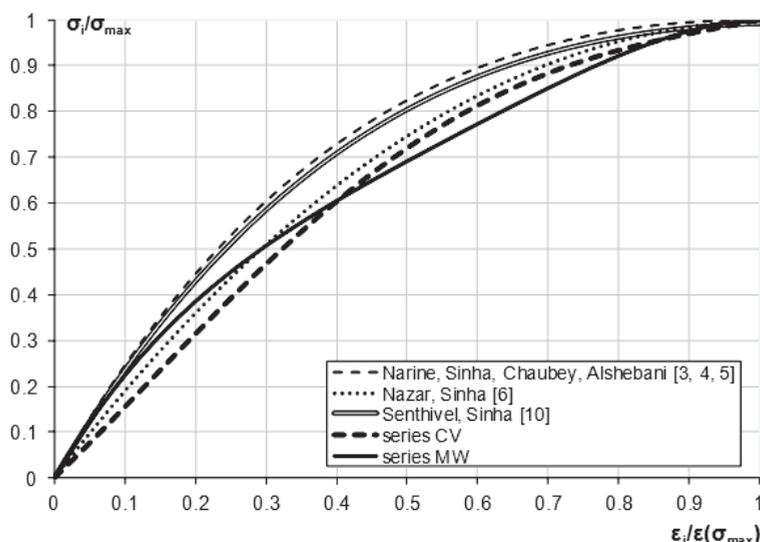
Fig. 9. Normalised $\sigma_i/\sigma_{\max,i} - \varepsilon_i/\varepsilon(\sigma_{\max,i})$ relationships for own and external research

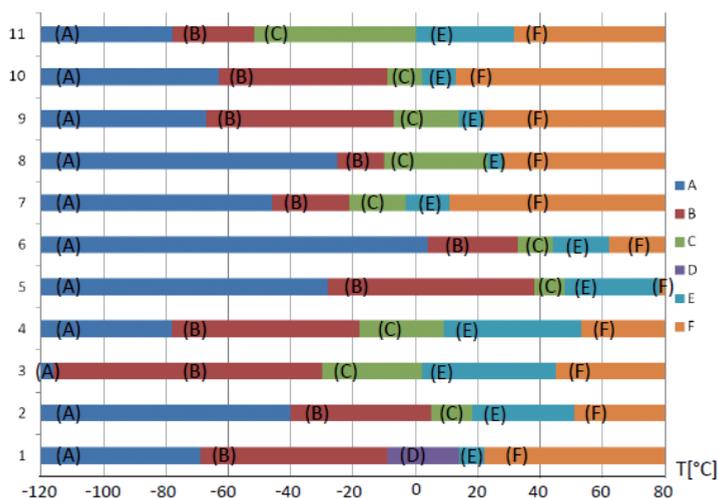
Fig. 2. Transformation temperatures for shape memory NiTi alloys (description in text)

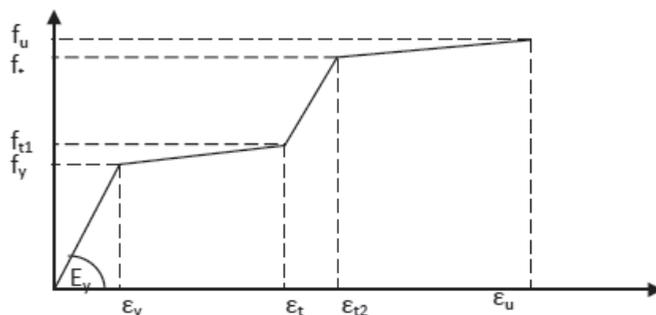
whole constitutive relationship will be shown properly if the test is starting from the austenite phase. An increase of stress from zero level will initially trigger a semi-elastic response from the alloy, followed by plastification and a yield-plateau. After phase transformation, the modulus of elasticity increases; finally the material reaches another plastification stress level and at increasing stress shows plastic deformation followed by rupture. The typical shape of the stress-strain diagram for the shape memory alloy is shown in Fig. 4.

Fig. 4. Stress-strain relationship for SMA material

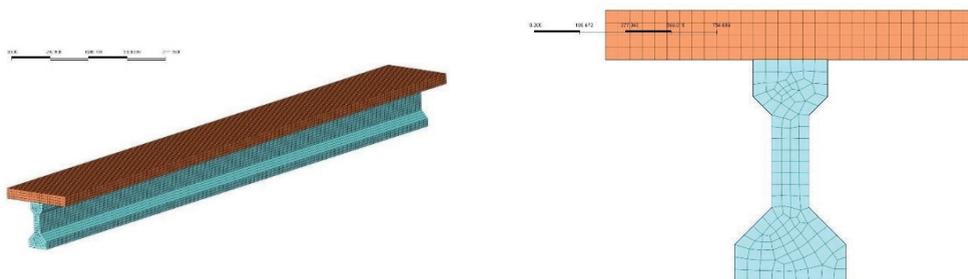
Fig. 1. Geometry of the modelled girder

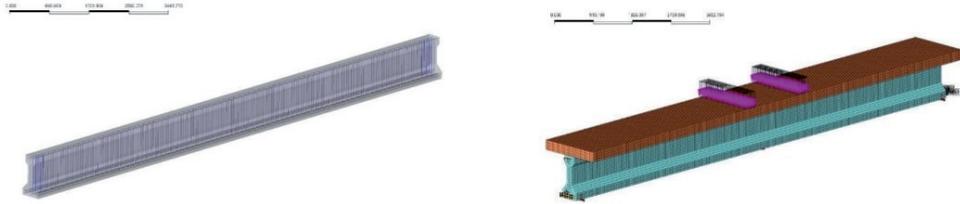
Fig. 2. Reinforcement, load and boundary conditions

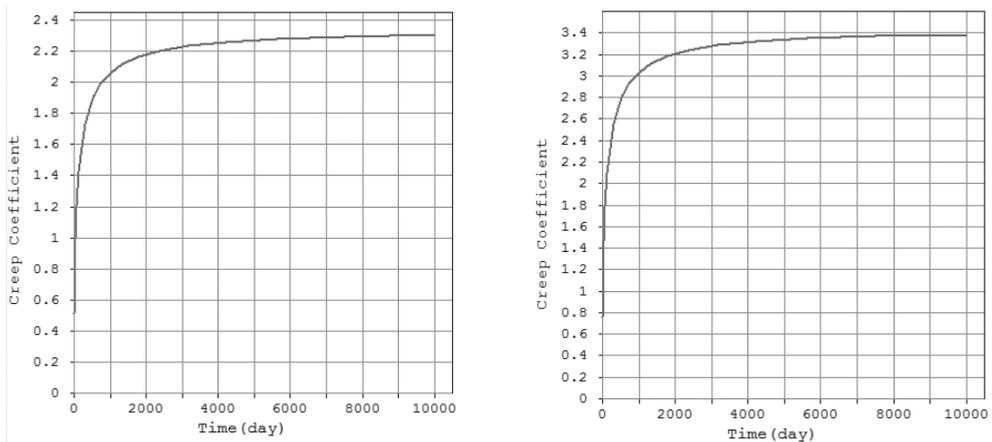
Fig. 3. HSC (a) and NSC (b) creep function

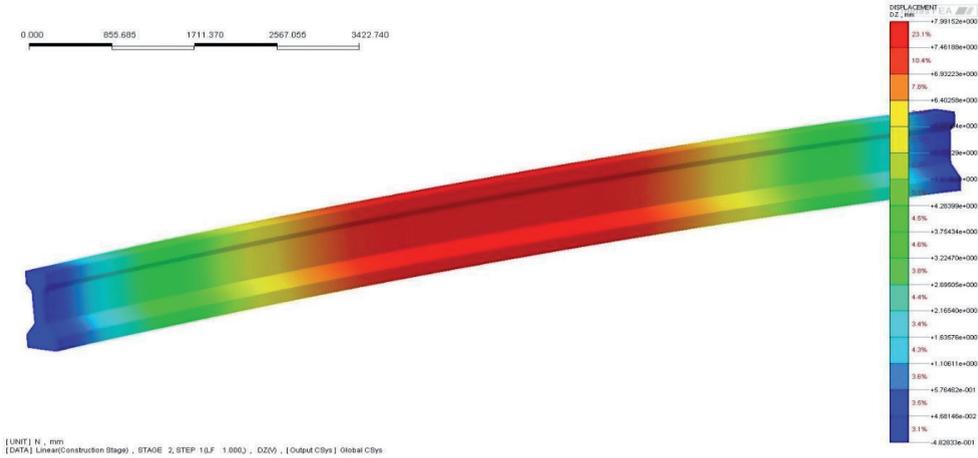
Fig. 5. Displacement due to pre-stressing

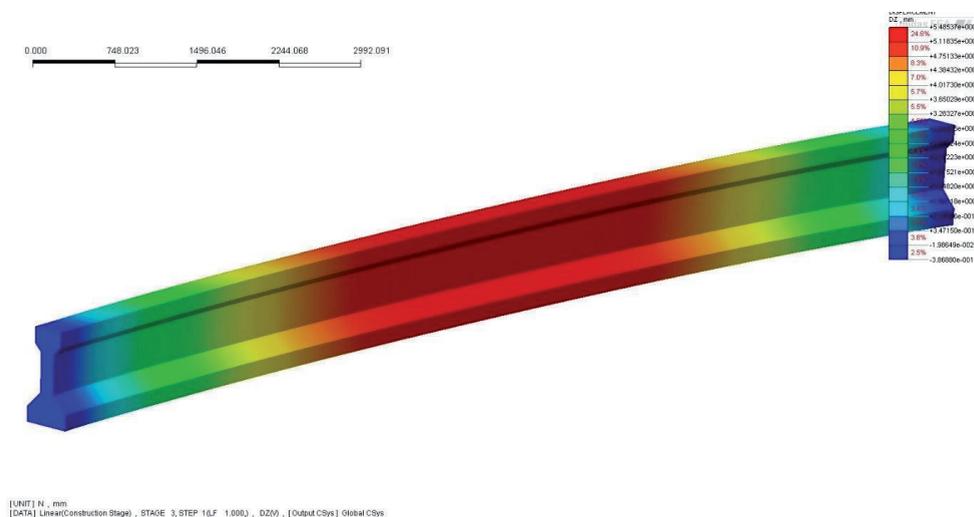
Fig. 7. Displacement after application of wet-concrete load

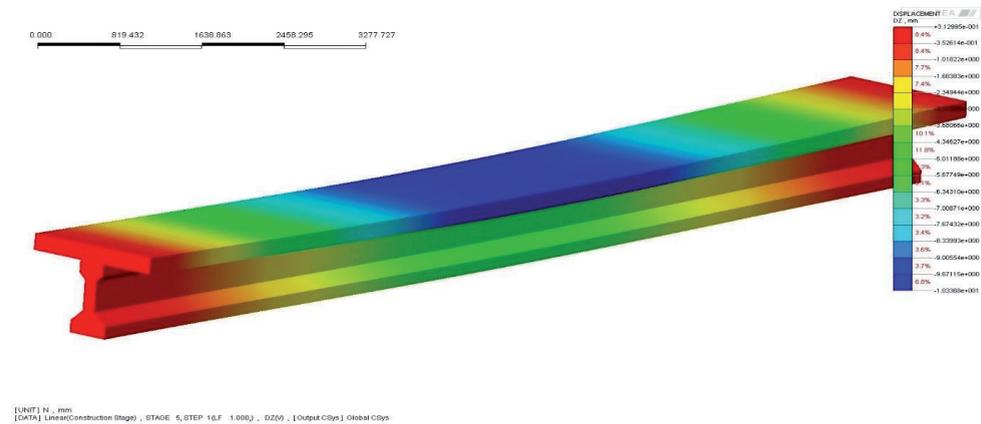
Fig. 9. Displacement after external cracking load application

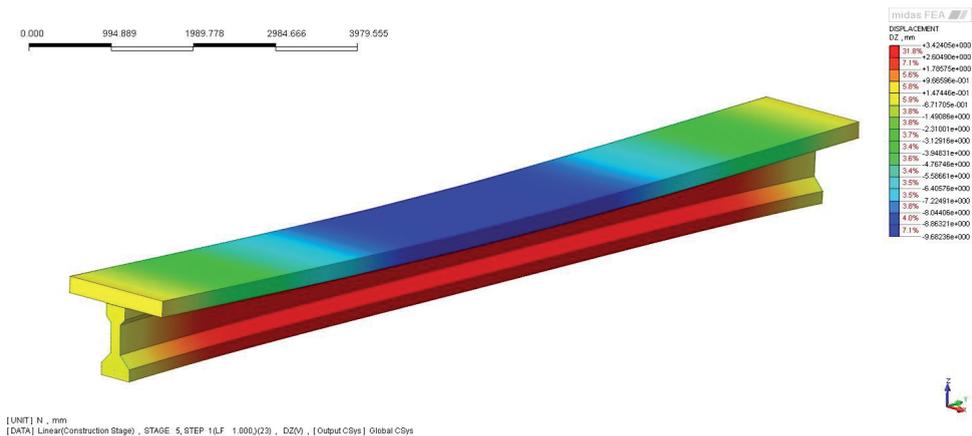
Fig. 13. Deflection of composite girder with creep

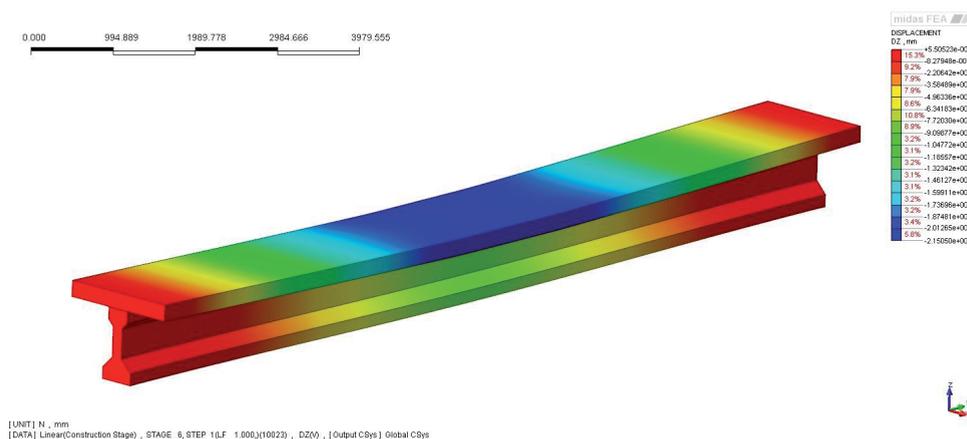
Fig. 14. Deflection of composite girder for long-term behaviour (10,000 days)

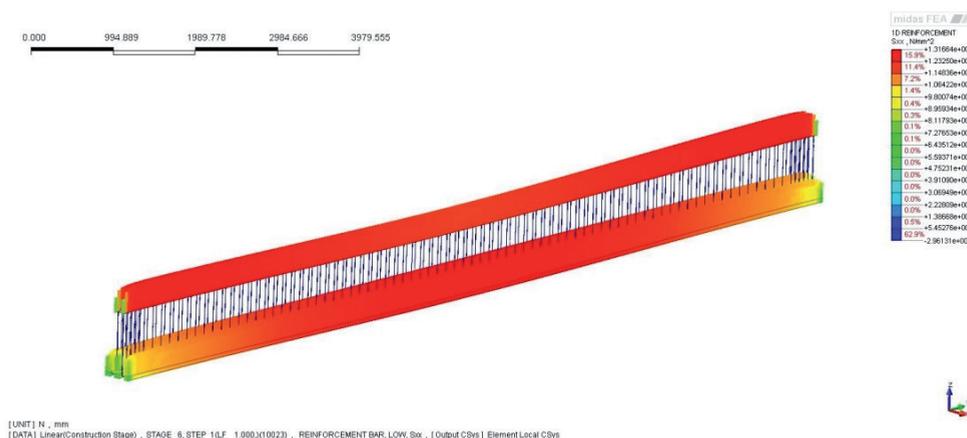
Fig. 15. Stress distribution along pre-stressing strands after 10,000 days

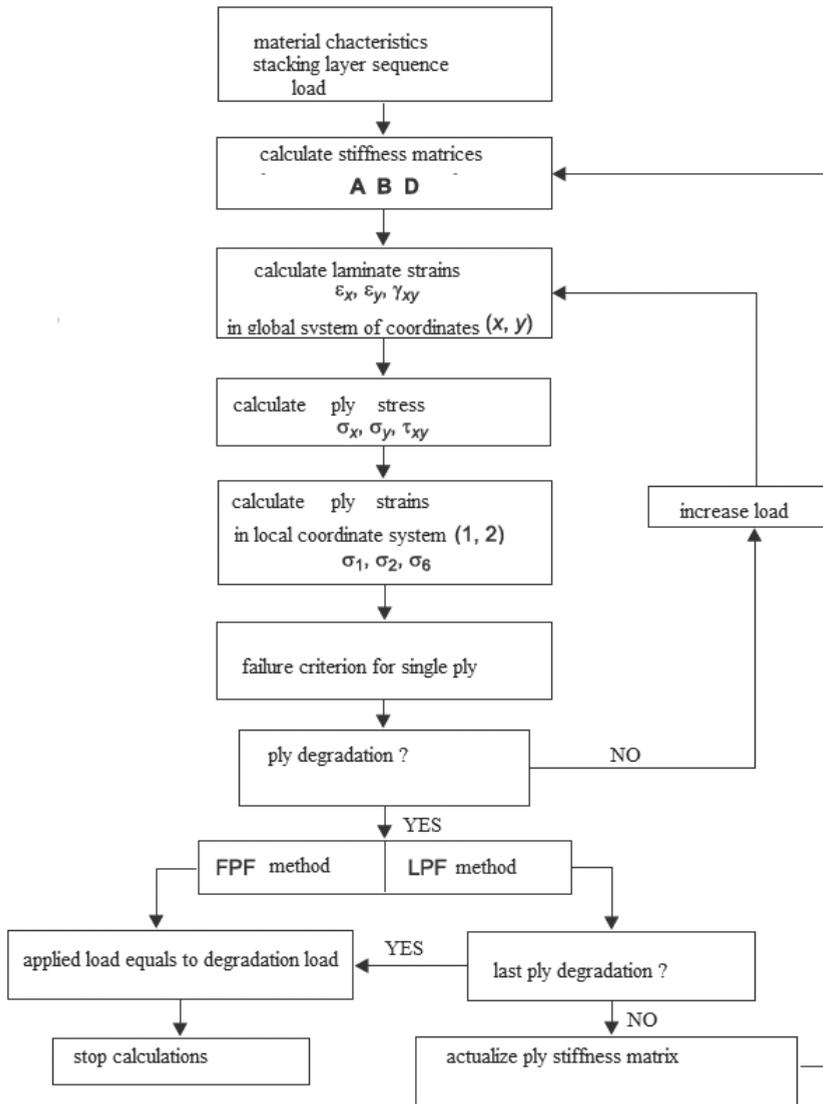
Fig. 3. Algorithm of strength analysis of composite laminate

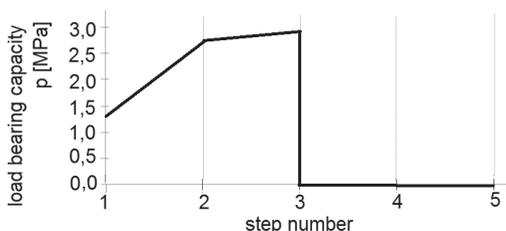
Fig. 5a. Load-bearing capacity in subsequent steps

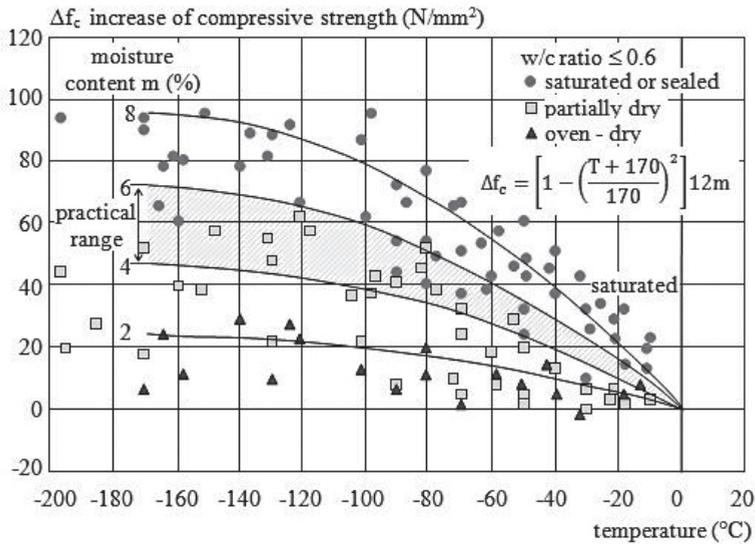
Fig. 3. Increase of compressive strength Δf_{cm} as a function of temperature and moisture content (Van der Veen, 1987) [9]

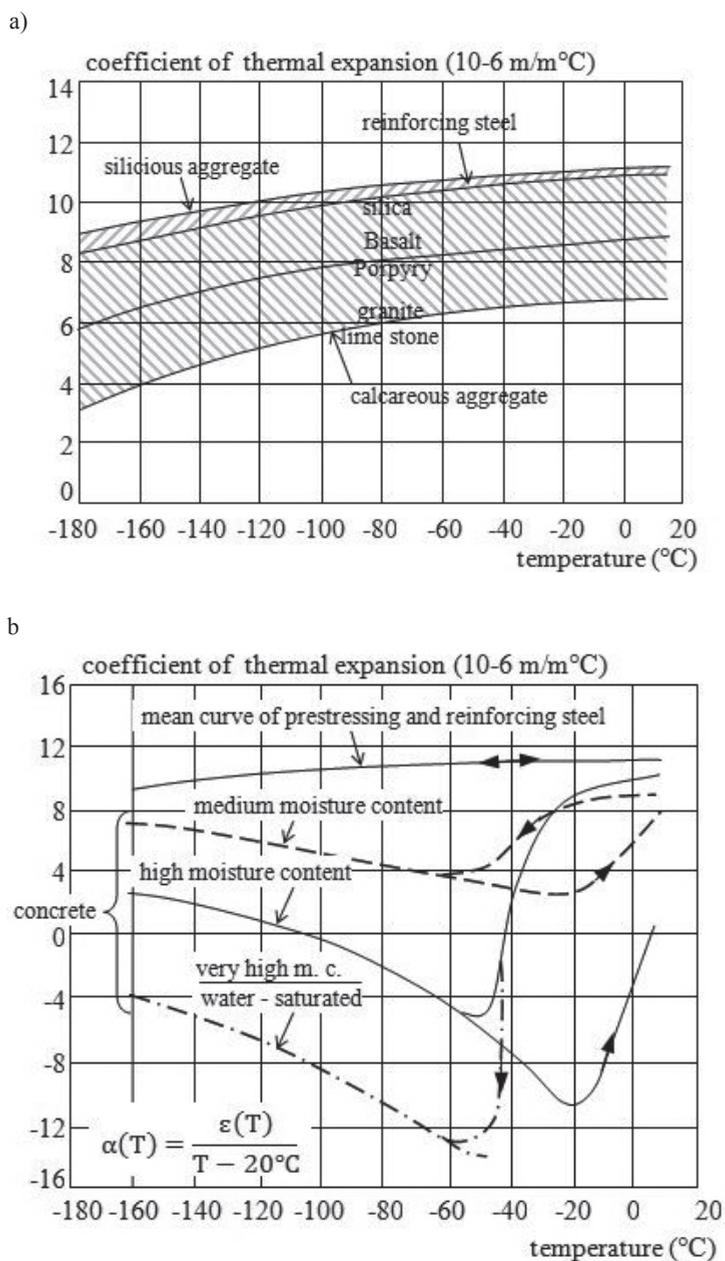
Fig. 5. Effect of a) type of aggregates, and b) moisture content, on the value of the coefficient of thermal expansion α_r [9]

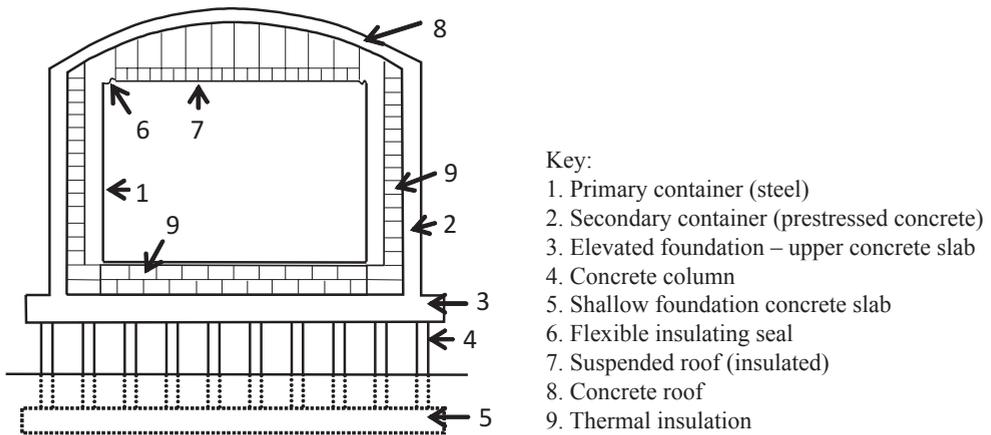
Fig. 6. Geometry of the cryogenic tank with pile foundation (according to EN 1473[12])

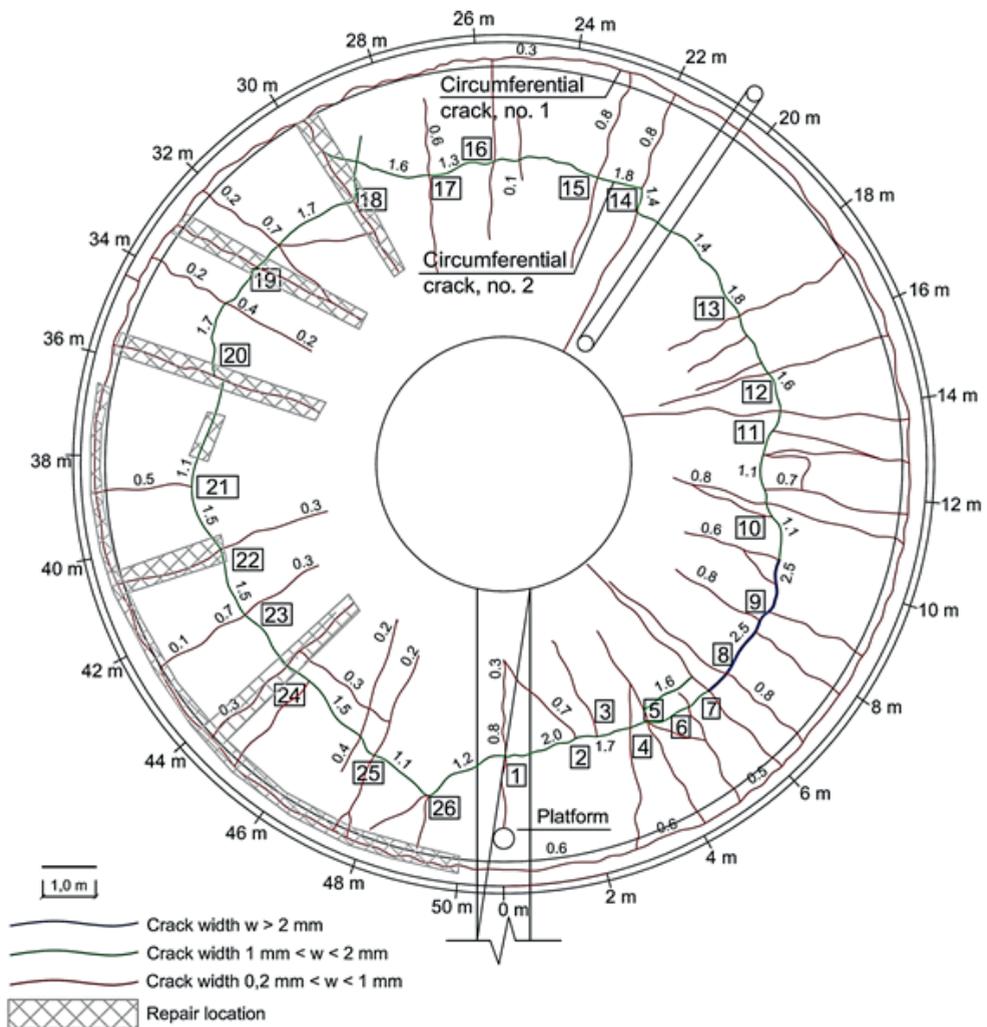
Fig. 3. The view of crack morphology on the outer surface of the tank's dome

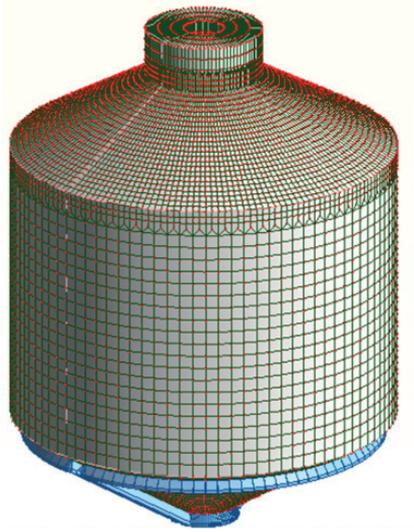
Fig. 4. The FEM model of the tank

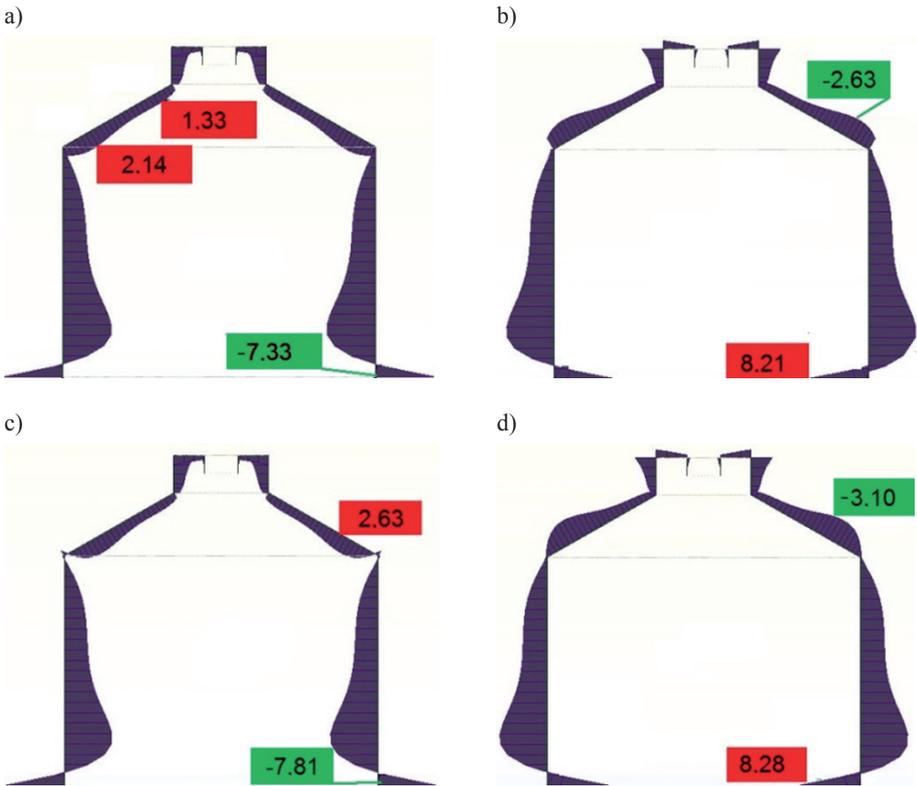
Fig. 5. The distribution of radial stresses: a), b) on the inner and outer surface during operation; c), d) on the inner and outer surface in the accidental (tank overflow) situation
