**TECHNICAL
TRANSACTIONS**

**CIVIL
ENGINEERING**

**ISSUE
3-B (23)**

**YEAR
2015 (112)**

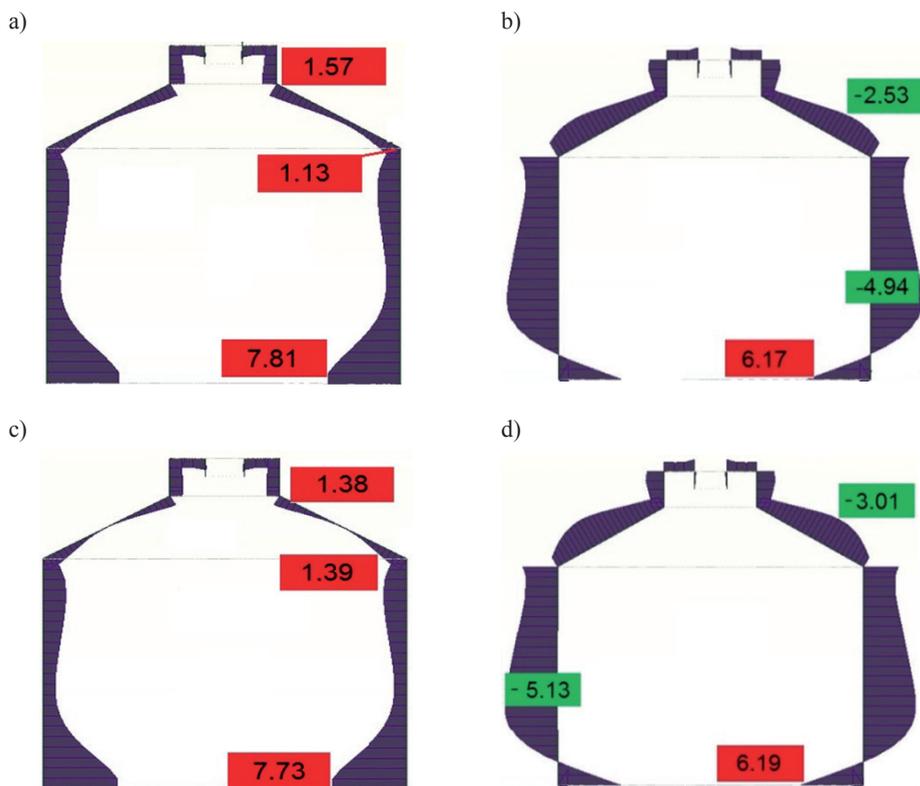
Fig. 6. The distribution of circumferential stresses: a), b) on the inner and outer surface during operation; c), d) on the inner and outer surface in the emergency (tank overflow) situation

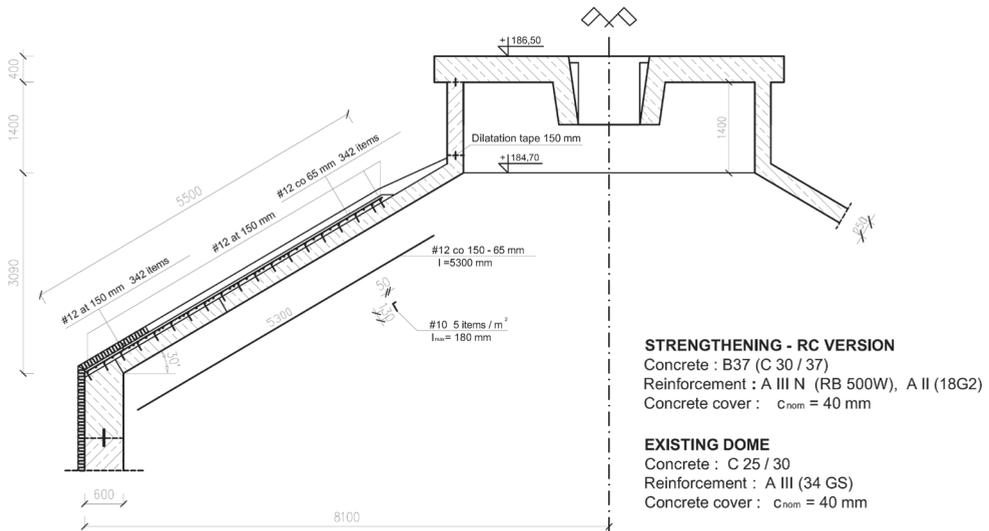
Fig. 7. Cross-section of composite shell

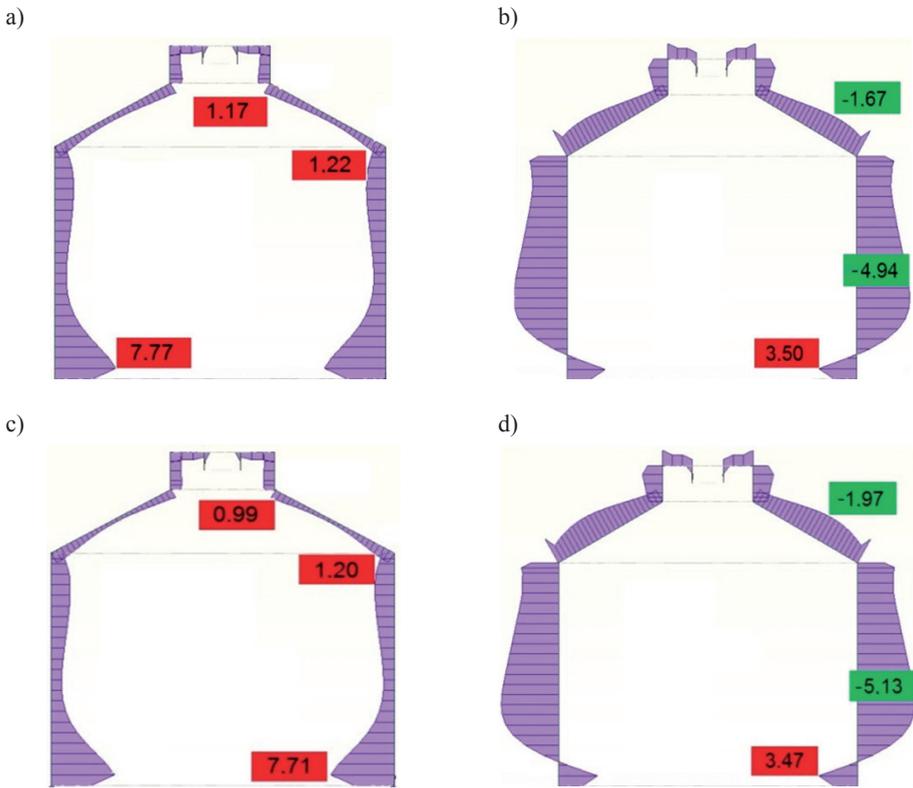
Fig. 9. The distribution of radial stresses in composite cross-section: a), b) on the inner and outer surfaces during operation; c), d) on the inner and outer surfaces in the emergency situation

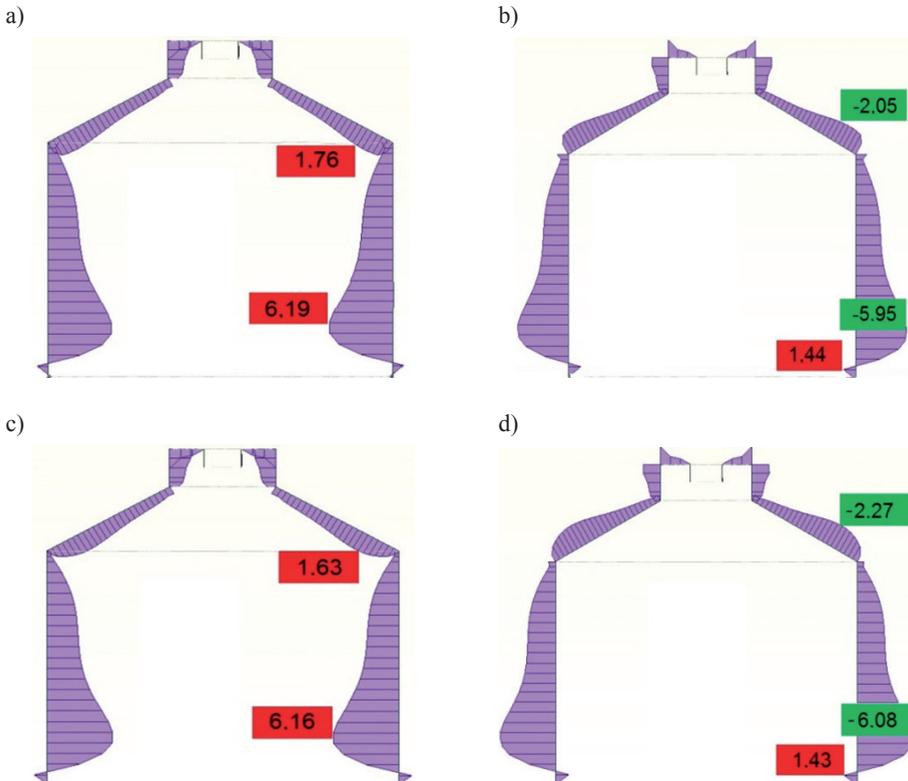
Fig. 10. The distribution of circumferential stresses in composite cross-section: a), b) on the inner and outer surfaces during operation; c), d) on the inner and outer surfaces in the emergency situation

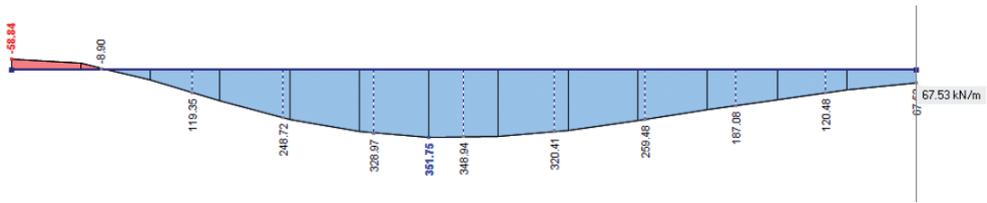
Fig. 11. Circumferential tensile forces due to hydrostatic pressure in the emergency situation

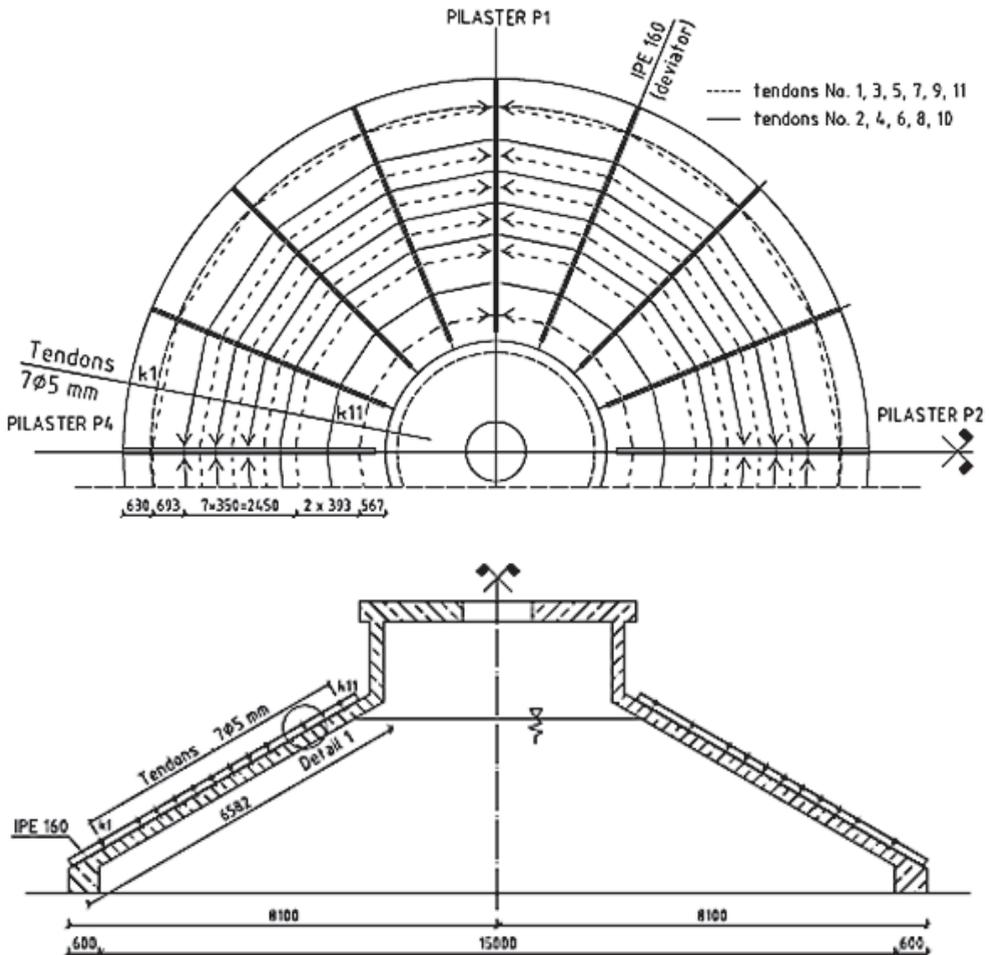
Fig. 12. Arrangement of deviators, pilaster and the tendons

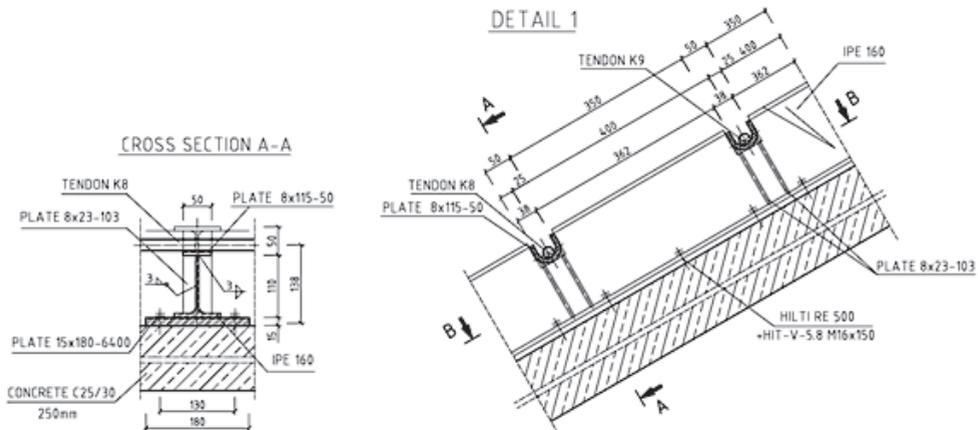
Fig. 14. The detail of the steel deviator

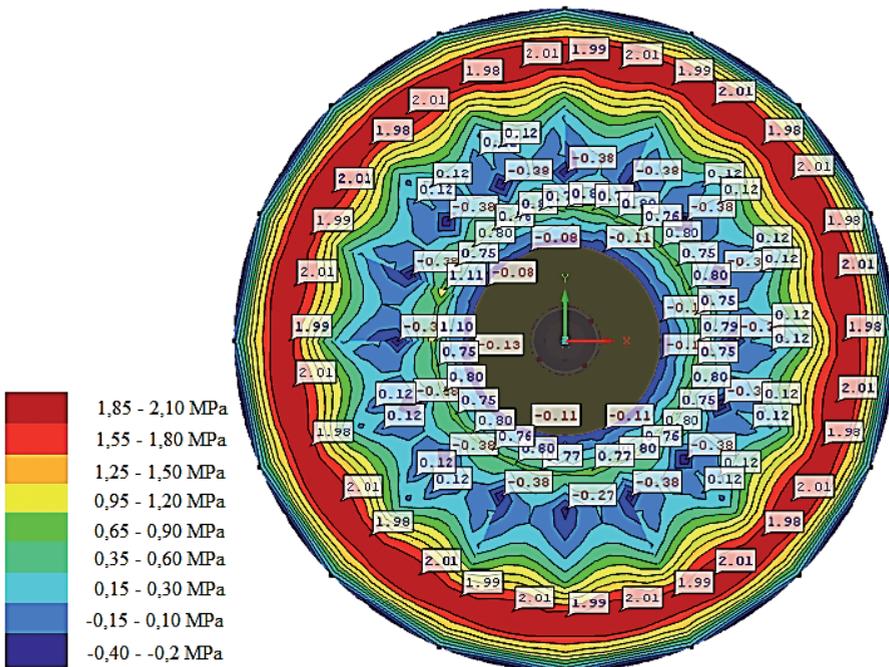
Fig. 16. The distributions of radial stresses on the outer surface of the tank's dome in the emergency situation

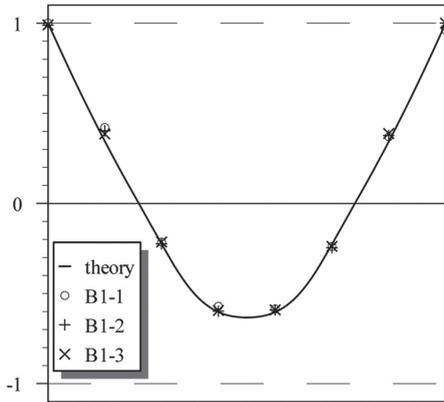
Fig. 6. B1 series primary eigenforms

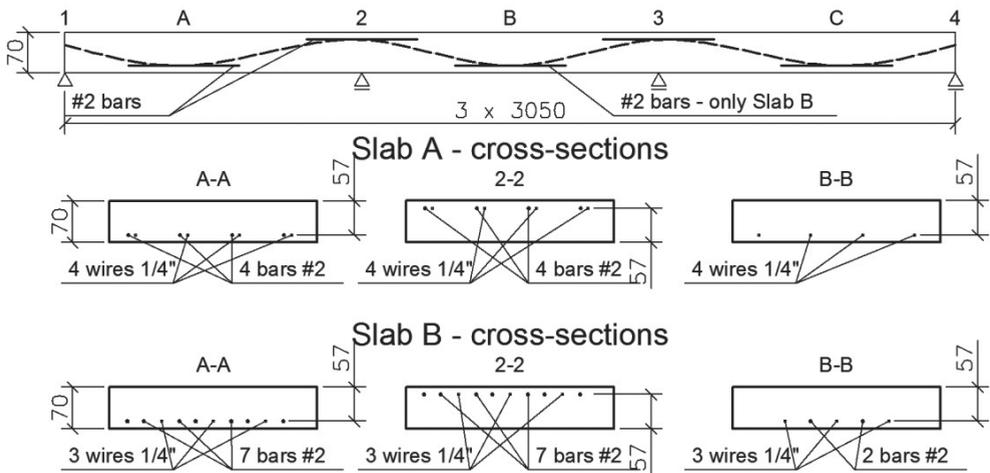
Fig. 1. View and cross-sections of members tested by Burns et al.

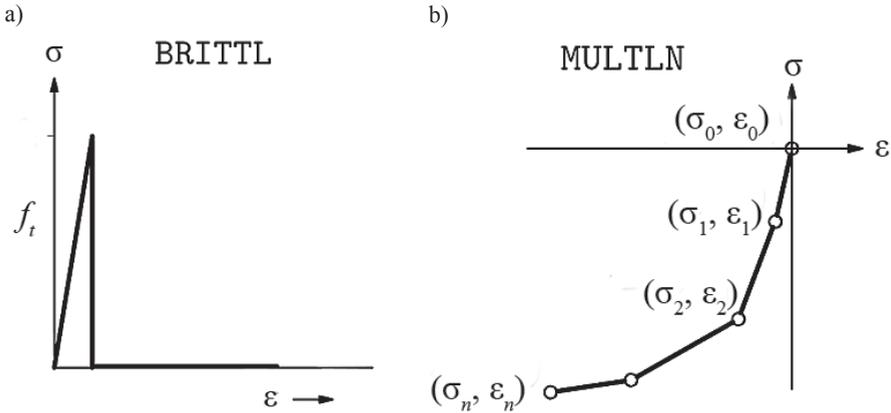
Fig. 2. Total Strain Fixed crack model for concrete a) in tension b) in compression

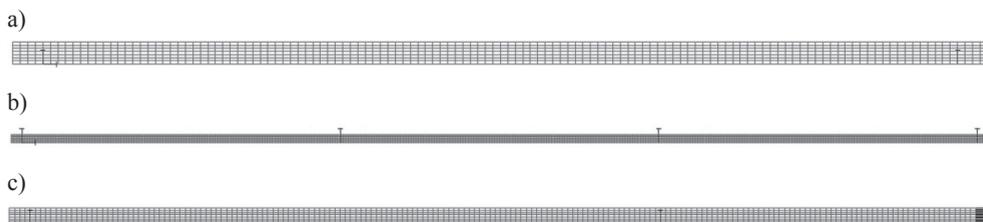
Fig. 6. Meshing for: a) single-span, b) three-span, c) one and semi-span model

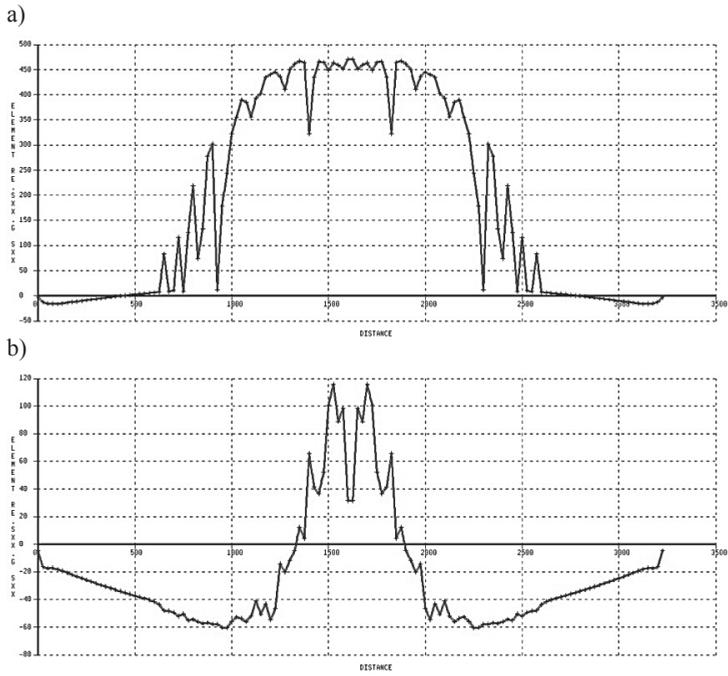
Fig. 7. Stresses in ordinary reinforcement in single-span model (100): a) bottom, b) top

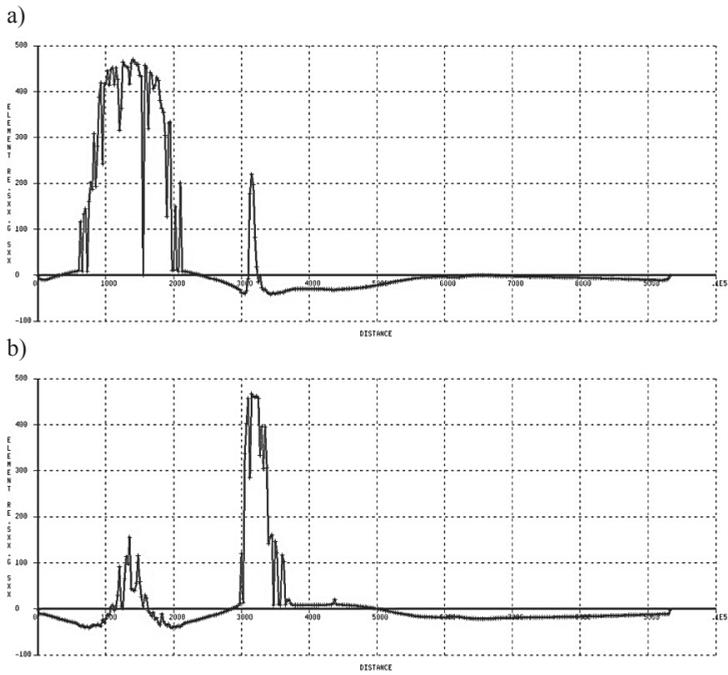
Fig. 8. Stresses in ordinary reinforcement in three-span model (111): a) bottom, b) top

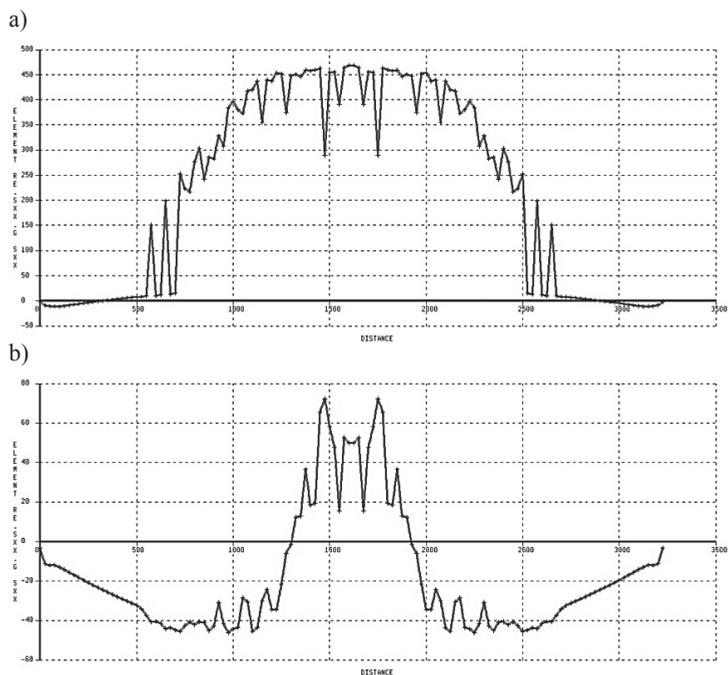
Fig. 13. Stresses in ordinary reinforcement in single-span model (200): a) bottom, b) top

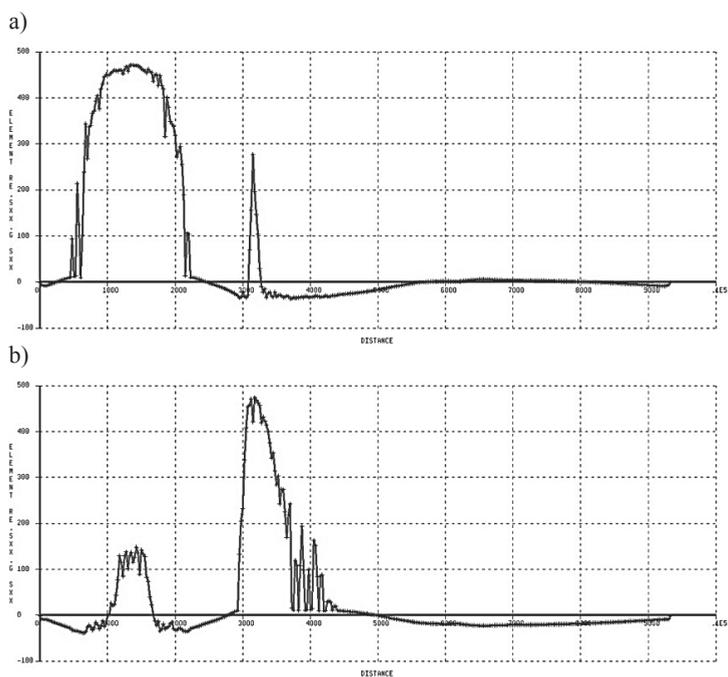
Fig. 14. Stresses in ordinary reinforcement in three-span model (211): a) bottom, b) top

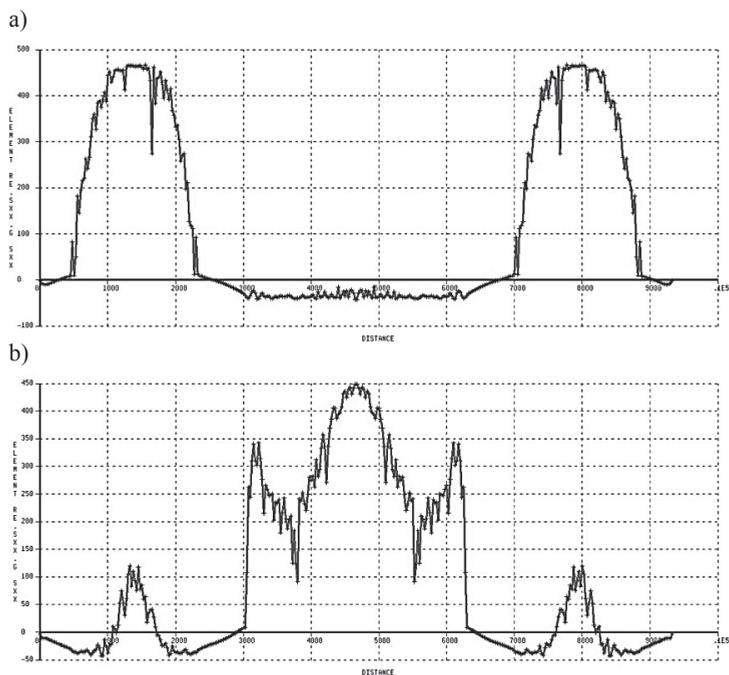
Fig. 17. Stresses in ordinary reinforcement in three-span model (214): a) bottom, b) top

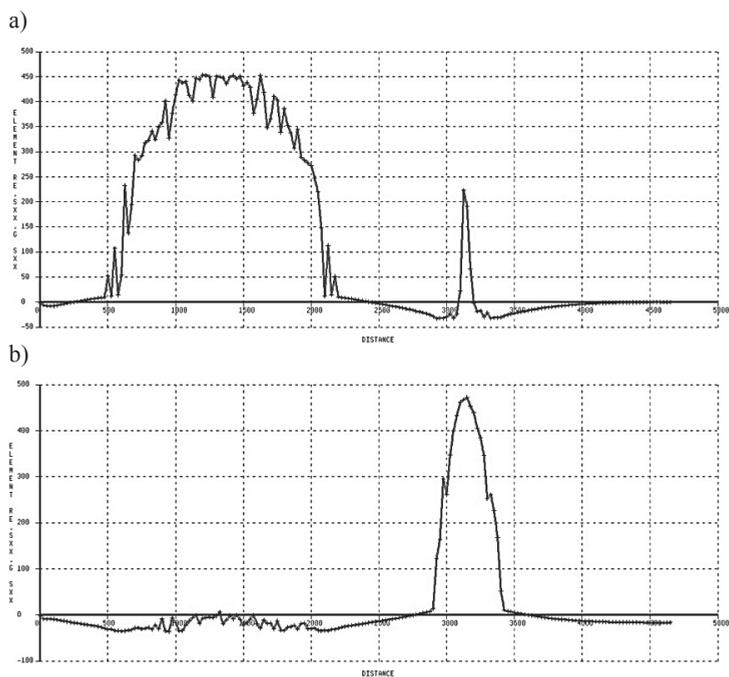
Fig. 18. Stresses in ordinary reinforcement in one and semi-span model (215): a) bottom, b) top

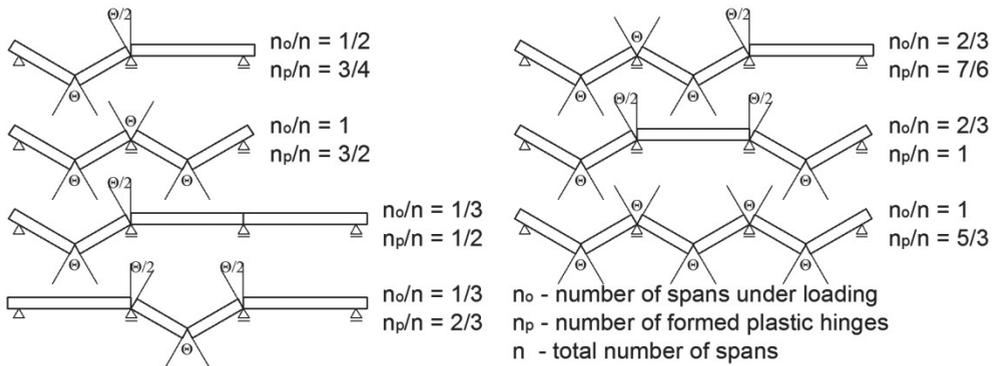
Fig. 19. Load pattern factor values – two- and three-span members
