Andrzej Białkiewicz\*

## OLD ARCHITECTURE – TODAY

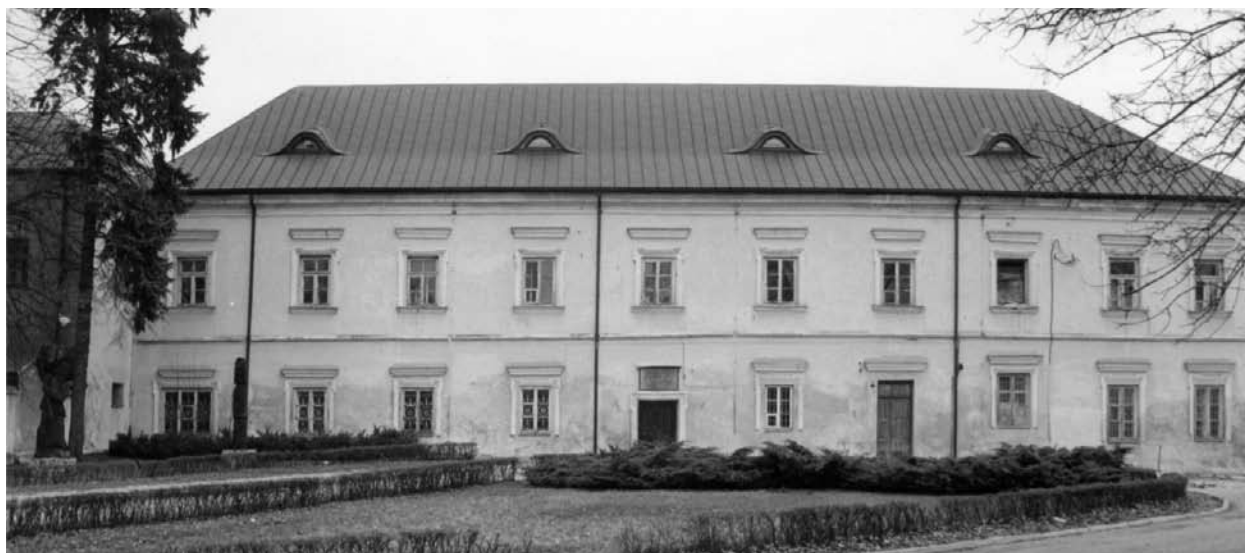
1. Włodawa, Paulinite Monastery, façade, 2001. Photo by author/ 2. Włodawa, Paulinite Monastery, façade, 2005. Photo by author

We should notice that the technical condition of the object was very bad despite the fact that it was constantly used and refurbished. In fact, the refurbishments were limited to immediate repairs, alterations and adaptations to the users' changeable needs. The roofing cover and the roof truss were in a very bad condition. The leaky water and canalization installations destroyed the interiors. The garth level, raised 1.2 m, and a lack of proper rainwater discharge from the roof as well as the area around the object contributed to the rising damp of the walls and floors within the ground floor. In order to prevent it, the users added countless layers of the floor raising its level and seemingly liquidating the dampness. However, the result was not a dry object. The cracked bearing walls, loosened vaults with fragments not supported by the walls anymore and hanging in the air against the principles of static, wretched window woodwork and peeling

plasters painted with oil inside and complemented with cement outside added to the overall technical condition. The interior was so altered that its original functional layout became completely unreadable. Office rooms appeared in the corridors, new room divisions, additional entrances and transport with narrow passages and little corridors were built.
