Shahira Sharaf Eldin*

Preserve and enhance existing sound housing stock – Wekalet El-Lamoun, Alexandria

2. WEKALET EL-LAMOUN AS CASE STUDY

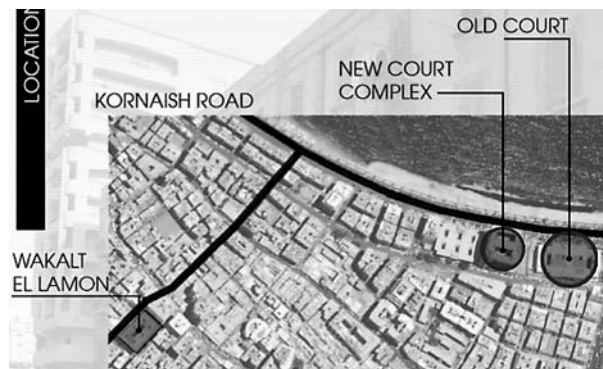
Fig. 4. Google map modified by the author

a number of other valuable streets in the city; those streets are "Souk El-Khodar street", "Masjed Terbana street", "Mohamed Korayem street" and ends at "El-kornish avenue" (fig. 4).

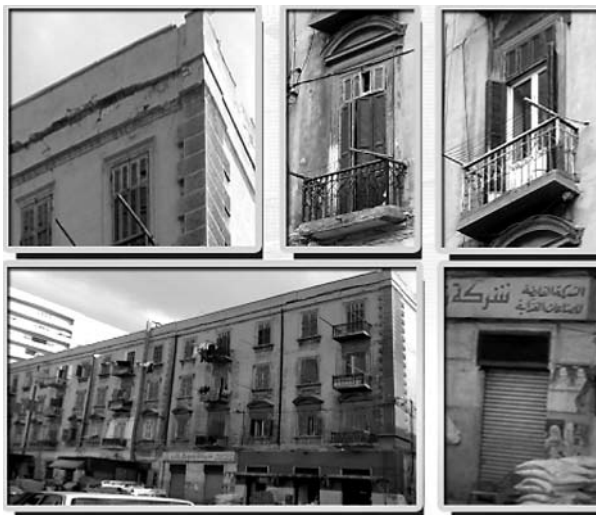
The litho type analysis done through this study revealed that Wekalet El-Lamoun walls main building materials are masonry units either stone or bricks. There are other different materials included in the elevations which are mostly used in windows and doors (fig. 12), such as: wooden shutter, steel balustrades, Aluminum shop fronts with rectangular ornaments lining the façades. Although the function of the building has not changed, the physical fabric has obviously altered [9].

Fig. 12. Photos showing the building façades current condition (Source: the author, 2010)

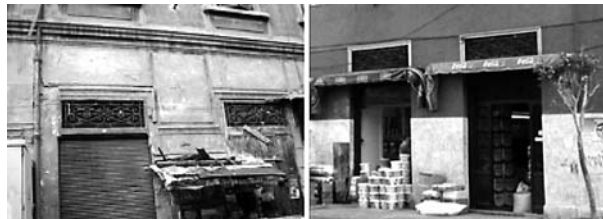
Alterations in form; For instance most of the stores still have their original front style but with changes such as different finishing materials and colors which are used regardless of the existing fabric of the building. Many of the shops also are currently just closed doors. Also, the signs of the stores in the ground floor destroy the aesthetic feature of the original building (fig. 13).

Fig. 13. Photos representing the store front of the building (Source: the author, 2010)

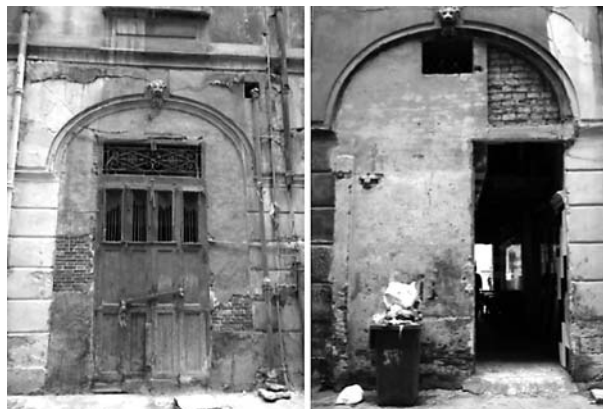
Another type of intervention is the closing of the entrances to gain more storage areas of shops or the changing of shops into warehouse (fig. 14).

Fig. 14. Photos representing the entrances of the courtyard [8]

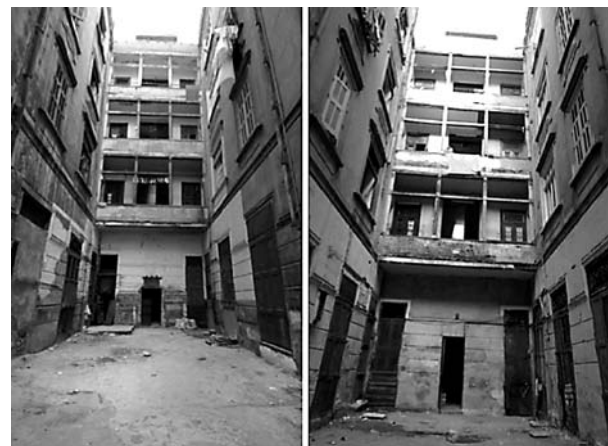
Fig. 18. Photos representing the staircases in relation to the upper floors [8]

- d. Deterioration features of the residential staircase: (fig. 18)
- Wear of the residential staircase.
 - Appearance of disjointing at the staircase walls' corners,
 - The appearance of vertical and inclined cracks with different lengths and widths.
 - Deviation and inclement in some walls.
 - Scaling of plaster finishing from the walls and bad paints.

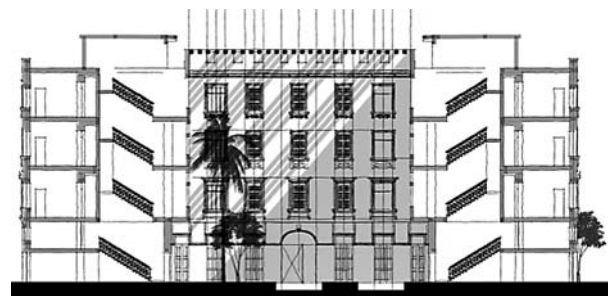
Fig. 19. Drawing representing the inner court and the stairs [6]

- e. Deterioration features of the courtyard and workshops: (fig. 19)
- Deviation and back weathering in some walls.
 - Unaesthetic choices of finishing material.
 - Appearance of vertical and inclined cracks with different lengths and widths in the first floor's wall.
 - Semi-total deterioration of flooring and ceiling.
 - Separation and falling of plaster finishes from the walls.
 - Bad condition of wooden ceilings, doors, and windows.
 - Appearance of rust on top of metal doors and windows.
 - The absence of paint finishing on the first floor courtyard façades.
 - The worn and missing of some stone cornices and carved stones.
