Testing timber beams after 130 years of utilization

Keywords: Reuse, Laboratory tests, Timber beams

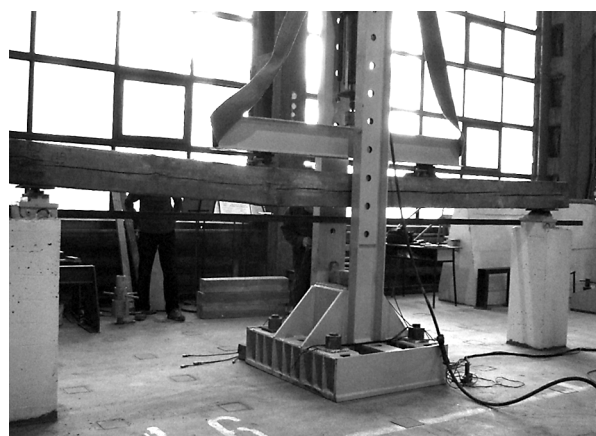
Fig. 4. View of the bending testing stand

beams BD3 and BD8 were tested with supports spacing equal $l = 4.0$ m. Actual length of tested beams decided about supports spacing. Scheme of the testing as well as the view of testing stand have been presented correspondingly in Figs. 3 and 4. During the testing force, deflections and strains on upper and bottom surfaces of the beam were measured.

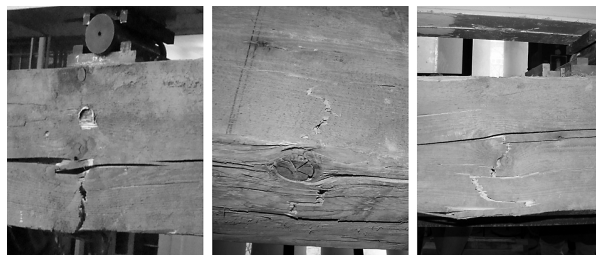
Fig. 6. Forms of beam destruction – from the left beams: BD6, BD5, BD2

Dependence of the deflection „u” on the applied load has been presented in Fig. 5 as a relationship: moment – deflection. This way of presentation results from the use of various spans in testing old timber beams and enables comparison of particular beams. As it has been shown in diagram presenting relationship moment – deflection for tested 130-year-old beams is clearly linear, different than in testing of new timber. Based on the extensometer measurements results, neutral axis lowering has not been observed either. Destruction of the beam usually happened in a violent way but it was preceded with classical cracks. Exemplary forms of destruction have been presented in Fig. 6.
