ŁUKASZ ZDANOWICZ*, RYSZARD WOJDAK**

STRUCTURAL ANALYSIS OF A FAILED RC BEAM WITH OPENINGS IN A BUILDING UNDER CONSTRUCTION

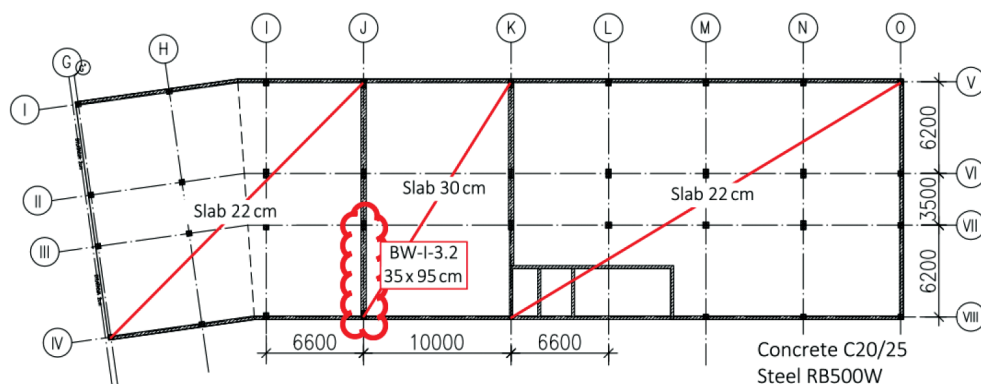
Fig. 1. The considered Floor Plan (defective beam marked)

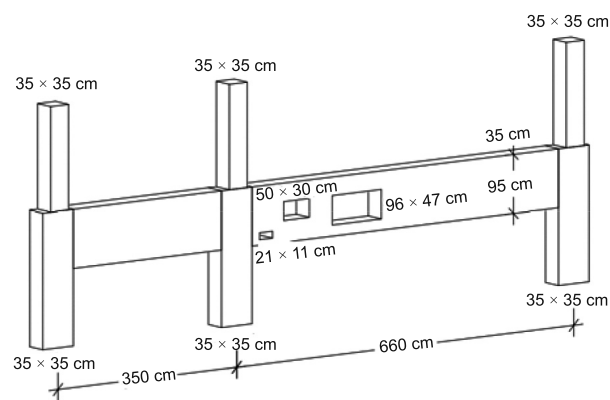
Fig. 4. Designed geometry of beam BW-I-3.2

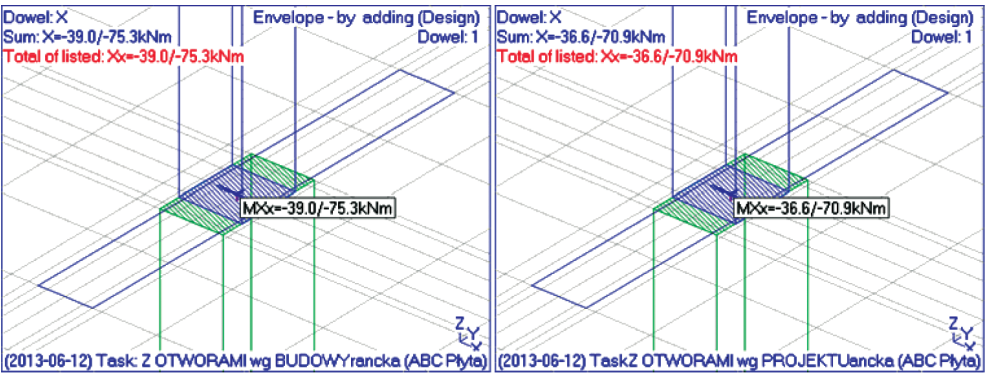
Fig. 5a. Moment in fixed support of beam with constructed openings (E)

Fig. 5b. Moment in fixed support of beam with designed openings (D)

It is worth paying attention to variation of the moment in fixed support along the beam M_x (cf. Fig. 4a and 4b) – the value of increment is equal to $\delta_M = 6\%$ (in comparison with model of beams without openings $\delta_M = 18\%$).

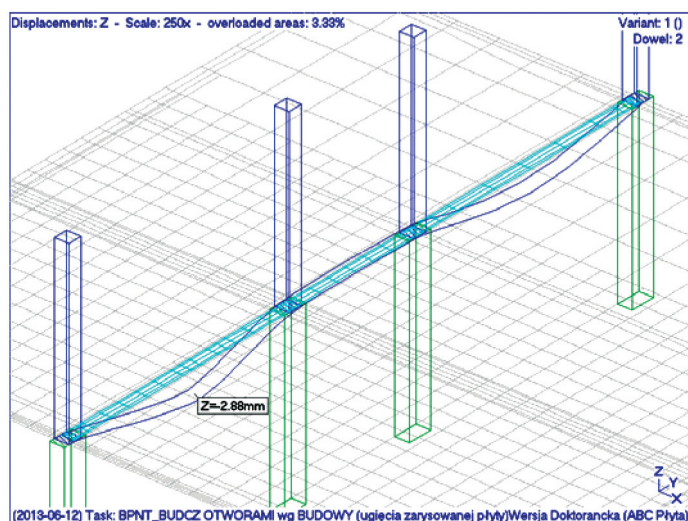
Fig. 6a. Deflection of beam with constructed openings (E)

The results indicate that the maximum beam deflections in (E) state are larger than deflection in (D) state, and the difference is approximately $\delta_f = 9\%$. In the beam without openings, the deflection equals $f_z = 1.70$ mm ($\delta_f = -36\%$ in comparison to (D), with a significant observation that this point is not a point of the maximum deflection, which in reality is located in another area of the beam and is equal to $f_{\max} = 2.16$ mm). It is caused by a change of the static system of the structure, where a redistribution of internal forces occurs as a result of local stiffness variation. The reduction of bending stiffness of cracked beams is not significantly different between (E) and (P) models – ca. 4%.

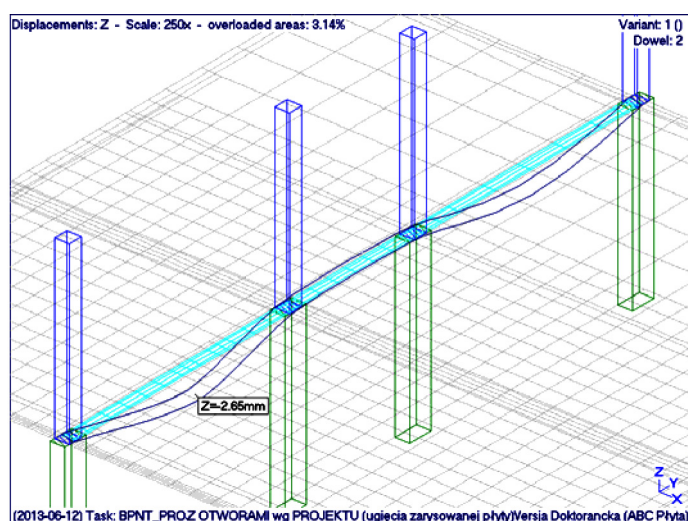
Fig. 6b. Deflection beam with designed openings (D)

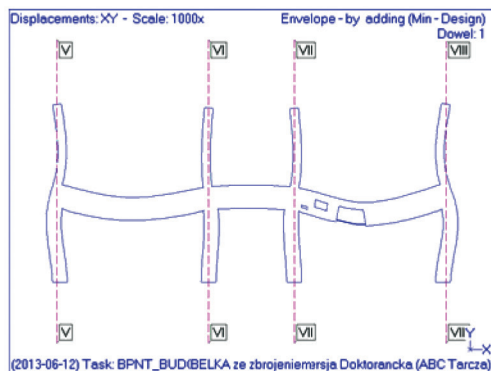
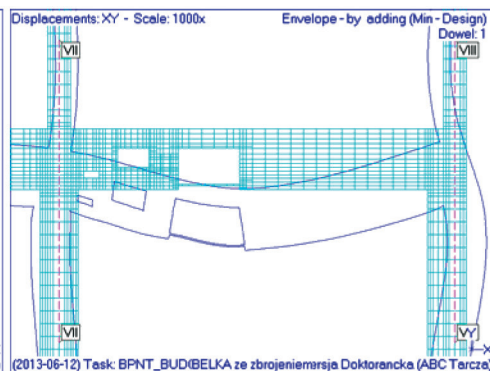
The disk model allows for the consideration of the shape and scale of deformations of the beam caused by openings (Fig. 7a and 7b). The tensile reinforcement at of the bottom of beam was modelled as an equivalent of 325 mm (cf. point 2.1).

The openings in the beam caused considerable changes in element curvature in the area of reduced stiffness of a section (area around the openings). It leads to a redistribution of internal forces which was not anticipated in the design phase. In the figures below, the principal stresses (σ_1, σ_2) from self-weight loads for beams (Fig. 8a and 8b) with and without openings (Fig. 9a and 9b) models are shown.

Fig. 7a. Deformation of beam in disk model

Fig. 7b. Deformation of beam (zoom of Fig. 7a)

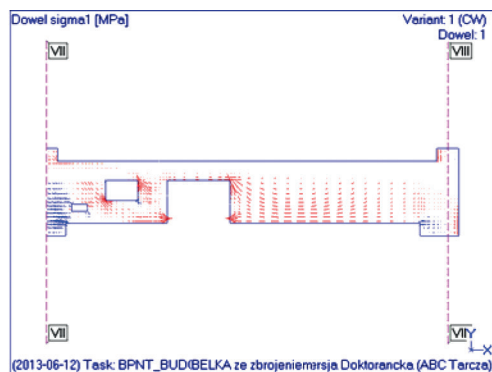
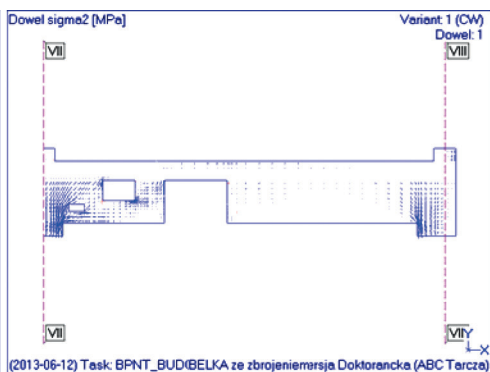
The beam openings significantly disturb the distribution of stresses in the considered cross-sections. A particular concentration of stress occurs along the edges of openings and around the corners of openings. The horizontal tension stress σ_x in an area of the largest

Fig. 8a. Principle stress σ_1 of beam with openings

Fig. 8b. Principle stress σ_2 of beam with openings

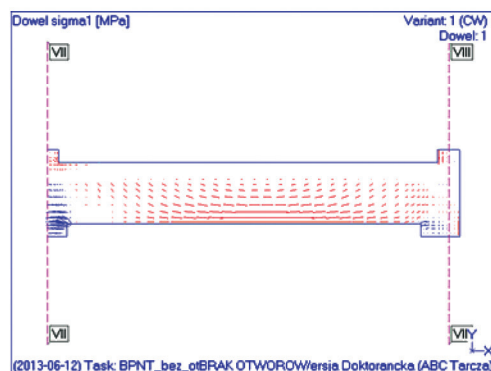
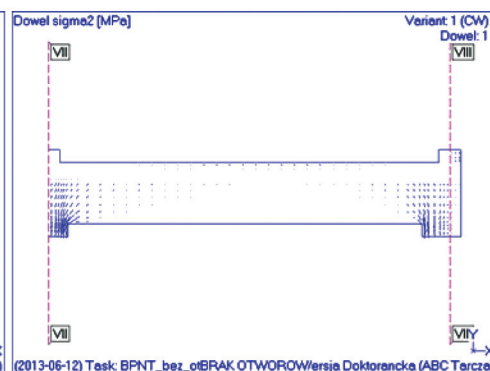
Fig. 9a. Principle stress σ_1 of beam without openings

Fig. 9b. Principle stress σ_2 of beam without openings

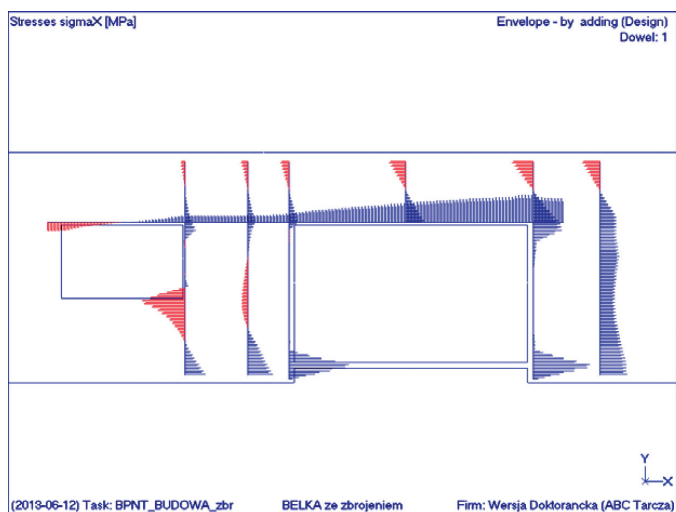
opening is concentrated at the bottom (represented by steel reinforcement). Simultaneously, the small part of these stresses is taken over by the slab, where the σ_x stress distribution is linear – as shown in Fig. 10. The stress σ_x in the area of the openings (but beyond the slab) is nonlinear (σ_x stress between the openings, Fig. 10). The visible move of the beam neutral axis in top direction (σ_x stress beyond the area of openings) is caused by interaction between the beam and the floor slab, which are monolithically connected. The distribution of vertical stress σ_y (similar to σ_x) is nonlinear, especially in the corner area of openings where there is a considerable variation of σ_y (Fig. 11).

Fig. 10. Stress σ_x

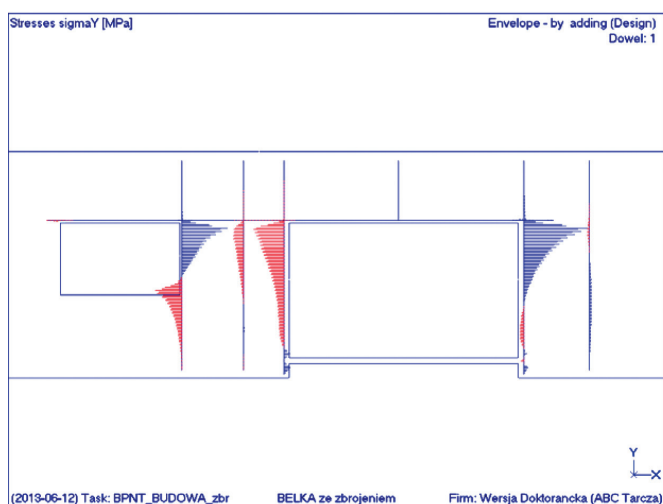
Fig. 11. Stress σ_y
