Andrzej Białkiewicz*

DURATION, PASSING AND A FUNCTION

maintained its identity for the seven ages of its persistence. However, we must ask a question: is the durability and fleetingness of architecture related to its function? I am going to present these problems exemplified by the St Barbara and St Andrew the Apostle's complex of a church, a monastery and a chapel "By the Source" in Częstochowa.

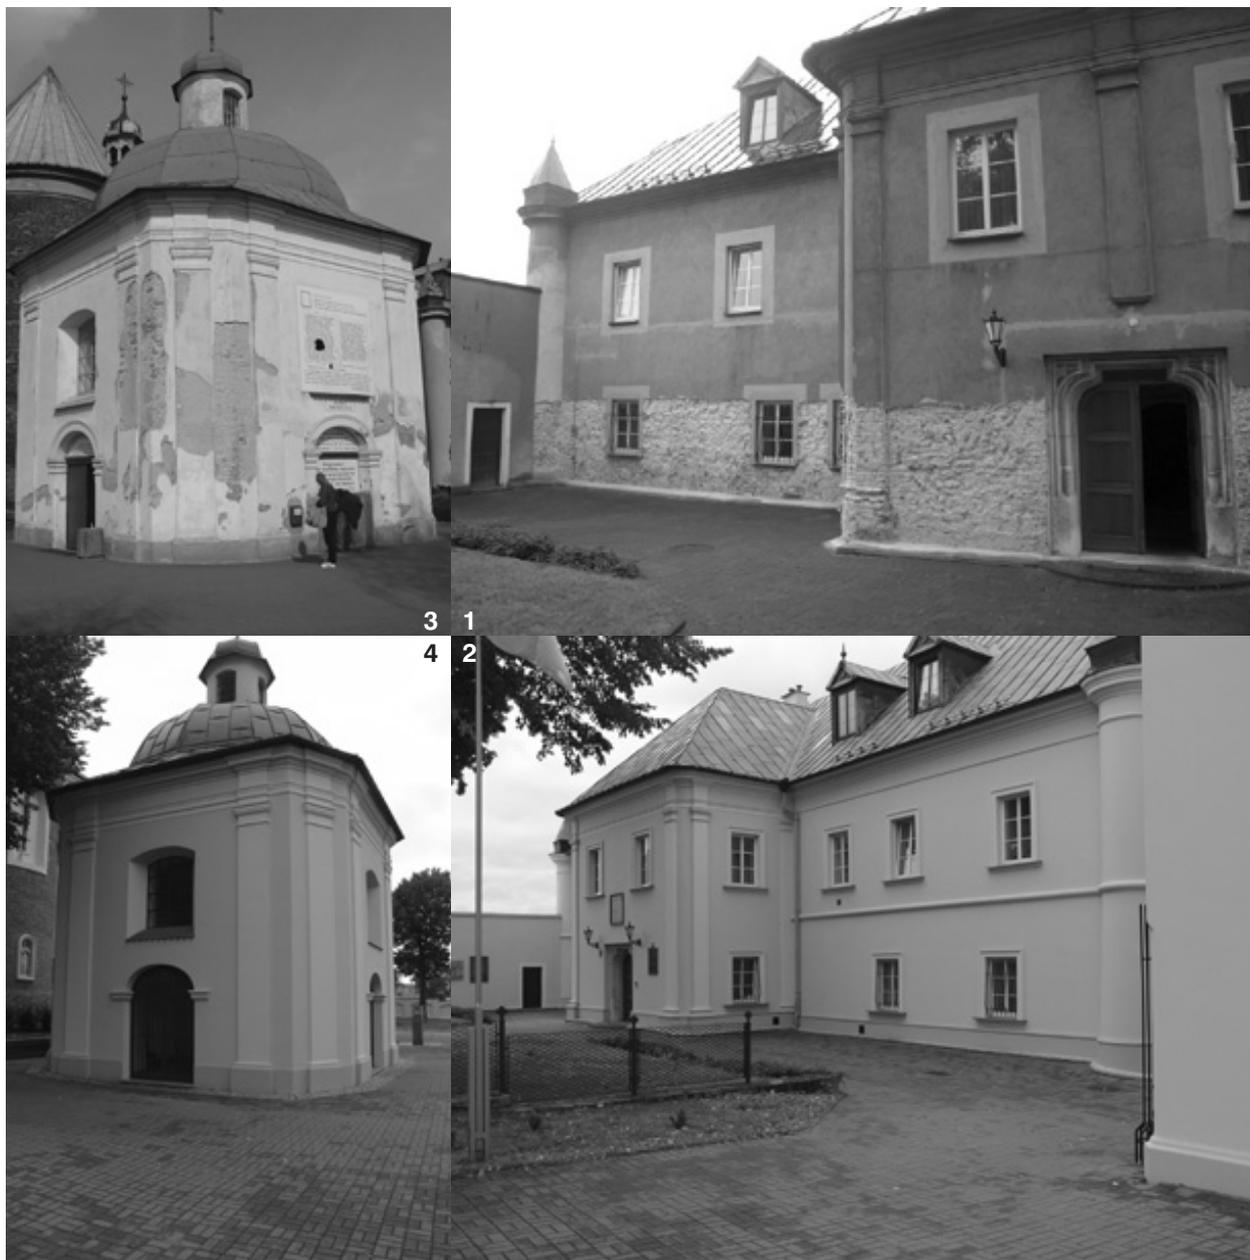
1. Częstochowa, St Barbara, Paulite Monastery, façade (photo by A. Białkiewicz, 2008)
2. Częstochowa, St Barbara, Paulite Monastery, façade (photo by A. Białkiewicz, 2011)
3. Częstochowa, St Barbara, Chapel "By the Source" (photo by A. Białkiewicz, 2008)
4. Częstochowa, St Barbara, Chapel "By the source" (photo by A. Białkiewicz, 2011)

On June 30, 1997, St Barbara and St Andrew the Apostle's parish was handed over to the Paulites. In 2006, a design of the restoration design of the facades of the church, the monastery and the chapel was prepared [9]. Generally, the restoration programme was limited to the preservation of the historically shaped form of the entire layout. In the existing composition of its body, principal stylistic stratifications were legible. The facades of the oldest part of the church were built of brick, whereas later forms were plastered. The design assumed maintaining a composition which made it possible

The design of the restoration of the monastery building assumed the standardization of façade tectonics, the restoration of original details, the reconstruction of removed cornices, pedestals and bands at the window openings. Recesses with bands were designed in place of the bricked-up window openings.

Legends say that a source gushed in the place where the Miraculous Painting of Our Lady of Częstochowa, stolen from Jasna Góra, was profaned in 1430. First, a wooden cross was placed here, then a water intake was created in the shape of a well and a shrine was built above it. Subject materials include information concerning the renewal of the Chapel. Certain items of information include drawings by Father Ignacy Pokorski dating from around 1732 where the Chapel was presented in forms similar to its contemporary image. In 1836, the Chapel was refurbished. In 1851, Paweł Mączyński painted Our Lady of Częstochowa for it. A description dating from 1860 shows us that there was a well inside the Chapel, an altar on its western wall and three doors in the form of iron bars leading to the interior [11]. The form of the well – the water intake was transformed which can be seen in photographs from the turn of the 19th century. At the beginning of our century, the Chapel was in a bad technical condition. The well casing structure and the altar top were gone, while the altar polychromy was fragmentary. The details of the cornices, the pilasters, the chapiters and the pilaster bases were destroyed. The design assumed restoring the original form of the Chapel with the reconstruction of the architectural details in its interior and on its facades as well as of the altar.
